Building Information - Wickliffe City (45088) - Wickliffe Elementary School

Program Type	Expedited Local Partnership Program (ELPP)
Setting	Small City
Assessment Name	Wickliffe_Elementary_2003_Assessment_With_2018_Cost_Set_Revised_11_02_18
Assessment Date (on-site; non-EEA)	2003-01-14
Kitchen Type	Full Kitchen
Cost Set:	2018
Building Name	Wickliffe Elementary School
Building IRN	20776
Building Address	1821 Lincoln Rd
Building City	Wickliffe
Building Zipcode	44092
Building Phone	440-943-0320
Acreage	2.29
Current Grades:	PK-4
Teaching Stations	38
Number of Floors	2
Student Capacity	422
Current Enrollment	558
Enrollment Date	2002-05-22
Enrollment Date is the date in which the current enrollment was taken.	
Number of Classrooms	32
Historical Register	NO
Building's Principal	Kelly Bearer
Building Type	Elementary

This facility was originally constructed in 1923 as a two-story building on the same site as Wickliffe Middle School. A basement area providing access to mechanical and crawl spaces is entered from the 1949 addition. The structure of the original building consists of concrete slabs on steel framing for the floors, load-bearing masonry walls, and wood framing for the roof. Ther

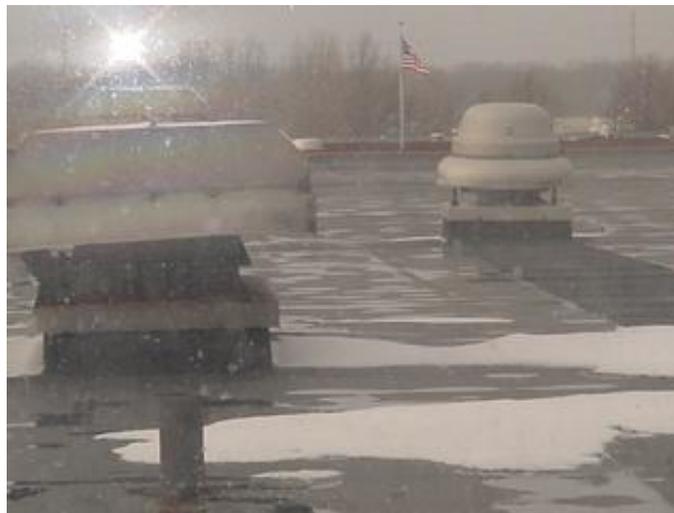
B. Roofing

Description: Approximately 65 percent of the roof area is a modified bitumen roofing system on concrete decks. These roof areas were installed in 1991, and they are no longer under warranty. Copings have deteriorated, and wall termination bars and flashings need repairs. The balance of the roof areas are 0.060 EPDM roofing on wood decks. These roof areas were also installed in 1991 and are no longer under warranty. Some flashings need repairs.

Rating: 3 Needs Replacement

Recommendations: Replace all roofing, copings, and flashings. Include tapered insulation to provide positive drainage. Allow for 10 percent of roof areas for deck repair/replacement.

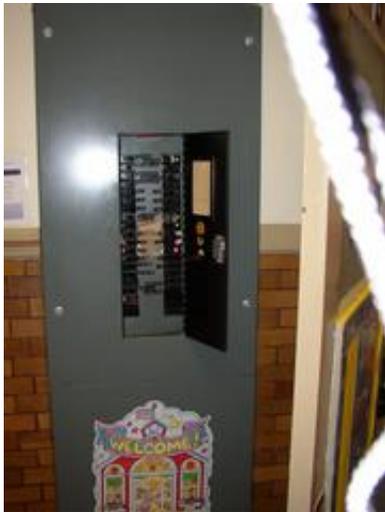
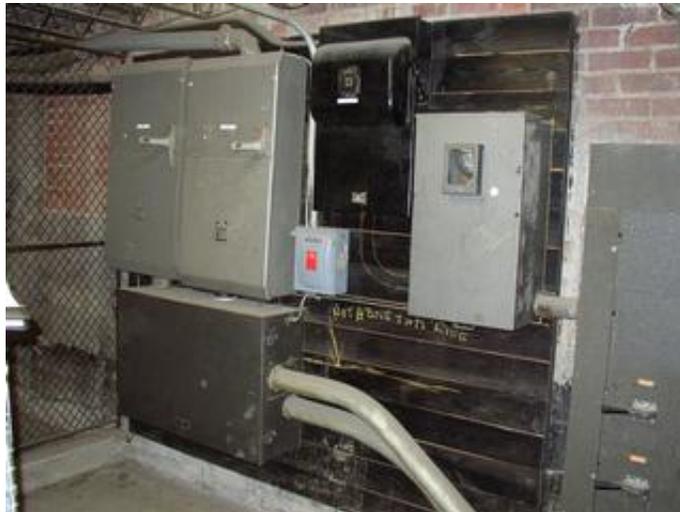
D. Electrical Systems

Description: The electrical service is located in the basement of the 1949 addition. It consists of two (2) 240/120 volt, 3-phase, 400 ampere main disconnect switches dating to the time of this addition. The service equipment is located in a dedicated area of the basement, and the power company's transformers are in an adjacent locked and fenced enclosure in the basement. The electric meters are reported to be obsolete and should be replaced. The electric service is in poor condition and is not of adequate capacity for new air conditioning loads. The electrical distribution system consists of circuit breaker panelboards located in corridors. The distribution system is in fair to poor condition and should be replaced.

Rating: 3 Needs Replacement

Recommendations: A new electrical service is required to provide additional capacity to power the proposed air conditioning. Panelboards should be replaced with new panelboards located in electrical closets. Additional branch circuits to instructional areas should be provided.

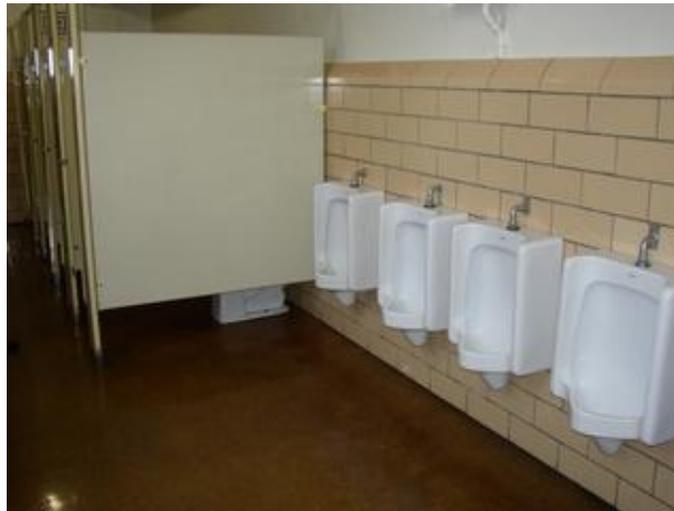
E. Plumbing and Fixtures

Rating: 2 Needs Repair

Recommendations: Replace all galvanized domestic water piping with copper. Provide a mixing valve on the domestic hot water system. Replace all floor-mounted water closets and other aging fixtures as needed.

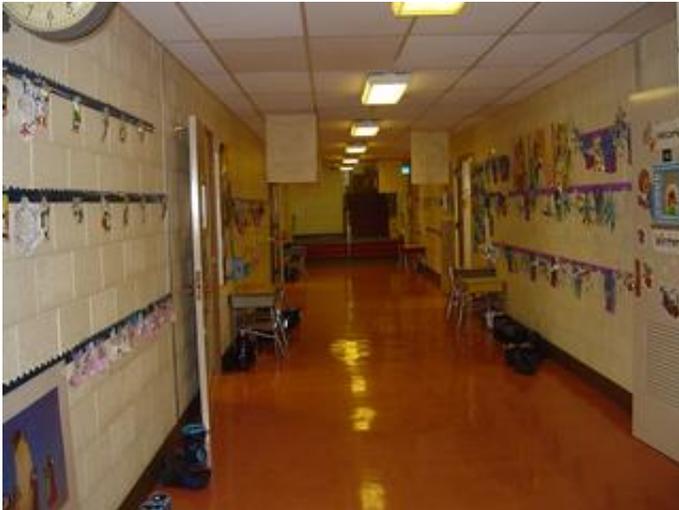
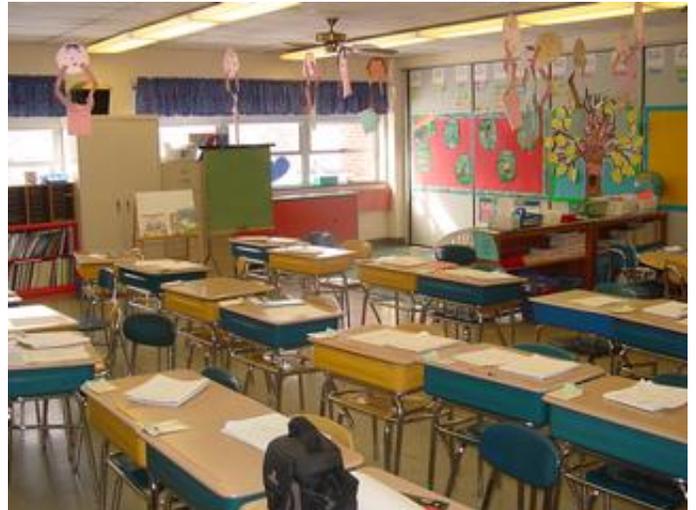
J. General Finishes

Description: Interior walls consist of brick, structural glazed facing tile, or painted concrete masonry units. The paint colors used are generally subdued, but they are compatible with the brick and tile. Most ceilings throughout the building are 2x4 acoustic panels in fair condition. The floors and walls generally have no acoustic treatment. Tackboards and chalkboards all appear to be in good condition. There is limited storage for student belongings and coats. Doors do not have accessible hardware, and they have non-safety glass. Toilet partitions are the original metal units, and they are in poor condition. The kitchen staff oversees the food service operation for all schools. The kitchen has insufficient space. Some of the cooking appliances are not located under a cooking hood.

Rating: 3 Needs Replacement

Recommendations: Replace all ceiling tiles and suspension systems throughout due to the installation of fire protection and ducted HVAC systems. Repaint all concrete masonry and gypsum board walls. The resilient flooring and carpeting should be replaced. Provide new storage units for student belongings. See Section O (Handicapped Access) for door hardware replacement. Replace door glazing with safety or wire glass. (We estimate the cost per door for glazing replacement to be \$150.00.) Replace all toilet partitions and toilet accessories. Provide a new cooking hood for the unprotected cooking appliances.

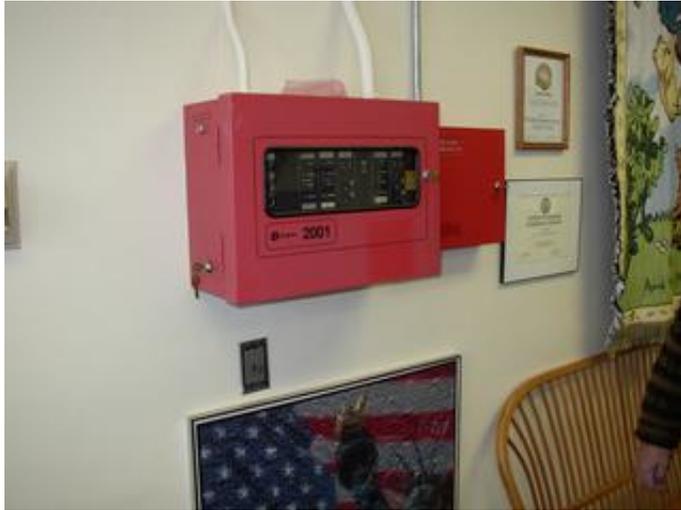
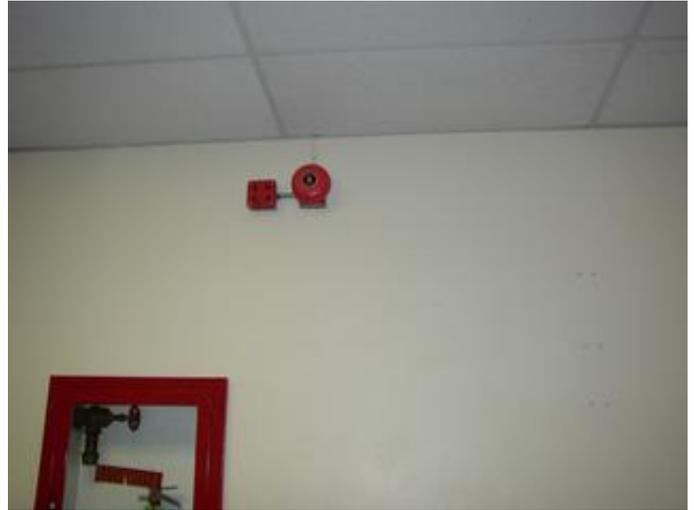
N. Fire Alarm

Description: The fire alarm system consists of a zoned fire alarm control panel (FACP) located in the school office. There are manual fire alarm pull stations, some ceiling-mounted smoke detectors, and audible wall-mounted alarm horns. The system does not meet A.D.A. or OSDM requirements. The system is in average condition and is not adequate.

Rating: 3 Needs Replacement

Recommendations: Replace the fire alarm system with an A.D.A. compliant system, including horn/strobe devices in the corridors, instructional areas, and toilet rooms.

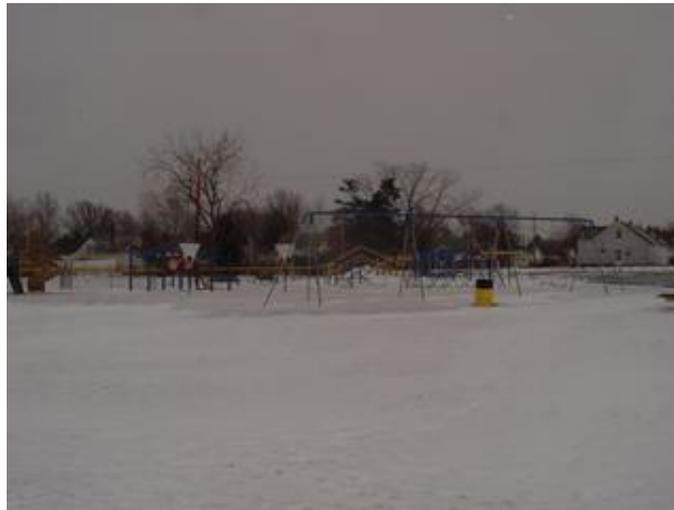
P. Site Condition

Description: The playground is well equipped and separated from the street and parking areas. The site is conveniently accessible to Euclid Avenue from Lincoln Road and is located in a quiet residential neighborhood. The site is adequately landscaped and includes educational programming. The site shows no signs of erosion. There is sufficient asphalt-paved parking in fair-to-poor condition. Concrete sidewalks, in fair condition, connect all building exits and site features. Curb cuts are provided where needed. The bus drop-off area is not segregated from other vehicular traffic. Adding a segregated bus loop is not feasible due to the lack of area. Other pedestrian and vehicular access to and through the site are adequately laid out.

Rating: 2 Needs Repair

Recommendations: Replace the asphalt parking area to the south of the building . Repair and overlay the asphalt parking/play area to the east of the building.
