Building Information - Wickliffe City (45088) - Wickliffe Middle School

GENERAL DESCRIPTION

92,798 Total Existing Square Footage
1920,1932,1963,2011 Building Dates
5-8 Grades
460 Current Enrollment
38 Teaching Stations
4.57 Site Acreage

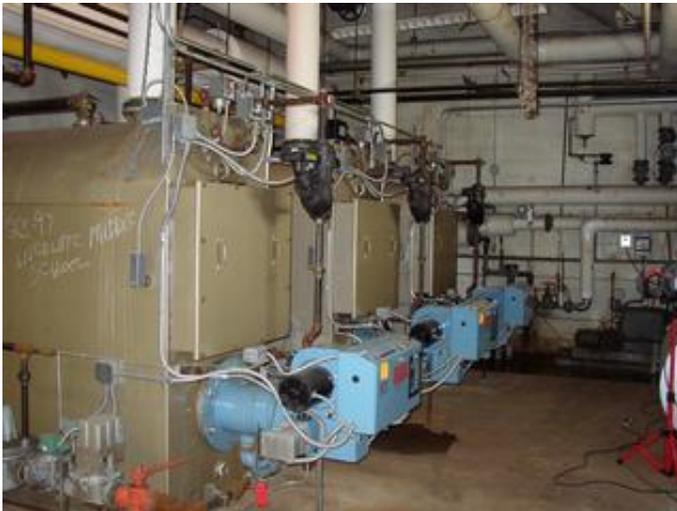
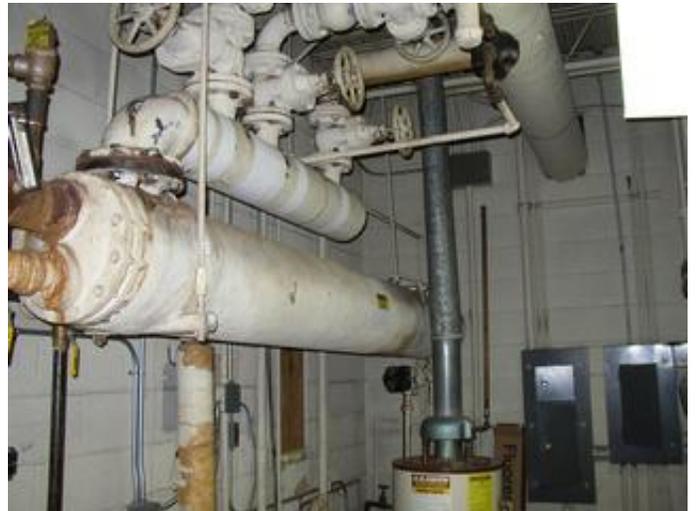
Description: The original 1923 building and the 1932 and 1963 additions are all served from a central boiler plant. There are three (3) gas-fired steam boilers, which all appear to be in good condition. Low pressure steam is distributed to the unit ventilators, convectors, radiators, and cabinet unit heaters in the 1923 and 1932 sections of the building. There are two (2) separate steam-to-hot water converters supplying heating water to unit ventilators in both of the 1963 additions. All of the unit ventilators were refurbished in 1997 and reportedly work properly. A Landis & Staefa System 600 direct digital control (DDC) system was installed in 1997 to control boilers, pumps, unit ventilators, and heating and ventilating units. We have assumed that the unit ventilator system does not provide sufficient outside air to meet current OMC and OSFC ventilation requirements. The school office, vocal room, and band room are all air conditioned from rooftop air-conditioning units. The range hood, ductwork, and exhaust fan are in fair condition, but date to the 1963 addition and should be replaced. The dishwasher hood and fan are in good condition and may be reused.

Rating: 3 Needs Replacement

Recommendations: Provide a complete replacement of the unit ventilator system with a ducted system that will supply conditioned air and provide the proper OMC outside air quantities to each space. Replace the steam boilers, the boiler auxiliary equipment, and all steam and condensate piping with hot water boilers and new piping. Air conditioning shall be added by the installation of a chiller, chilled water piping, pumps, and cooling coils. The DDC system should be expanded to control all new HVAC systems.

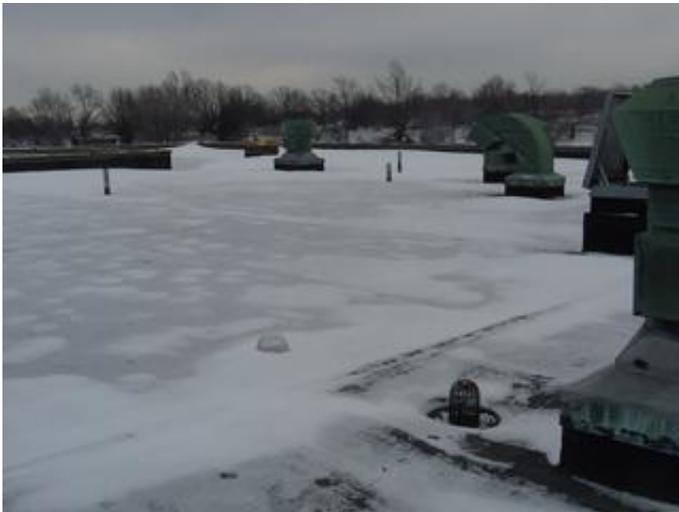
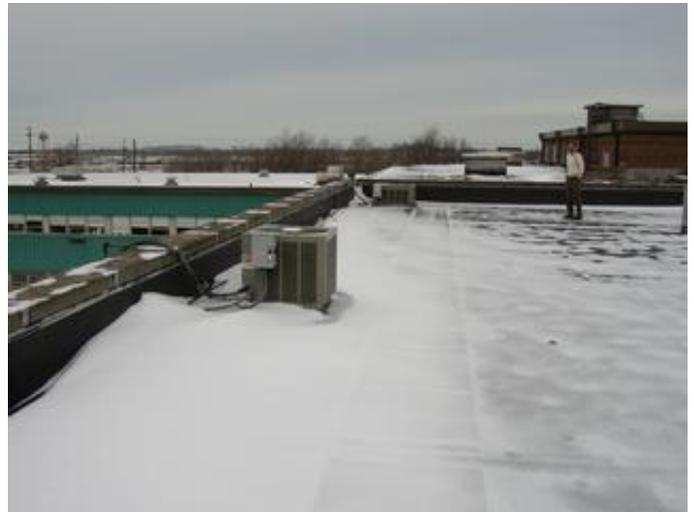
Description: All roof areas are 0.060 EPDM roofing with minimal slope and some ponding. These roof areas were installed in 1991-1992, and they are no longer under warranty. Wall termination bars and flashing need repairs.

Rating: 3 Needs Replacement

Recommendations: Replace all roofing, copings, and flashings. Include tapered insulation to provide positive drainage. Allow for 10 percent of roof areas for deck repair/replacement.

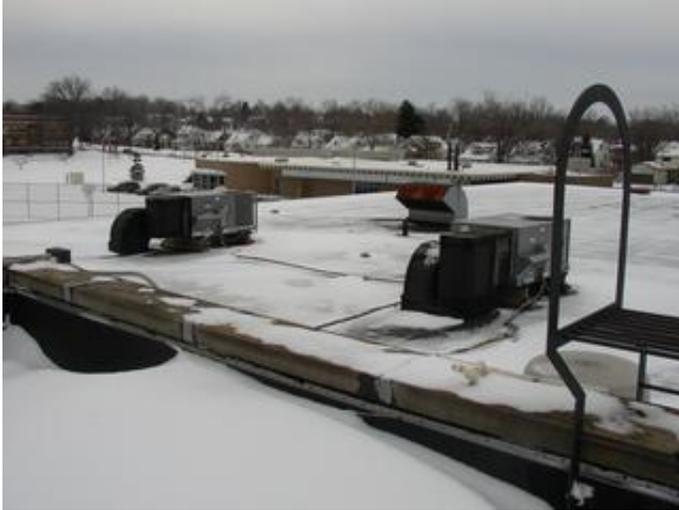
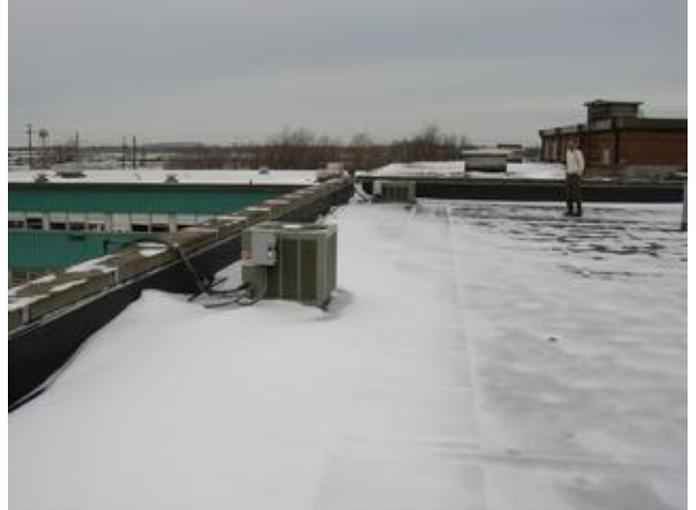
C. Ventilation / Air Conditioning

Description: The unit ventilators throughout the building provide some ventilation air; however, the outdoor air quantities are assumed to be insufficient to meet current OMC and OSFC requirements. The boys gymnasium heating and ventilating unit does provide fresh air to the gym, but the equipment is 40 years old and should be replaced. Air conditioning is limited to the school office, the vocal room, and the band room. There is no make-up air to the kitchen range hood.

Recommendations: Provide air conditioning. These costs are included in the complete HVAC system replacement in Section A (Heating System).

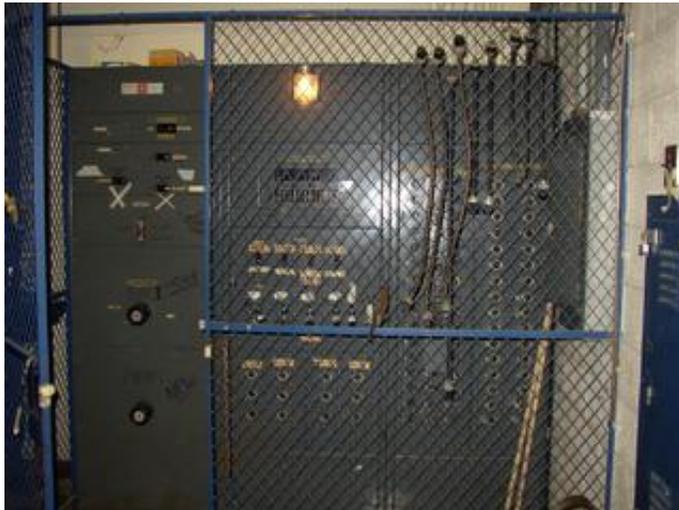
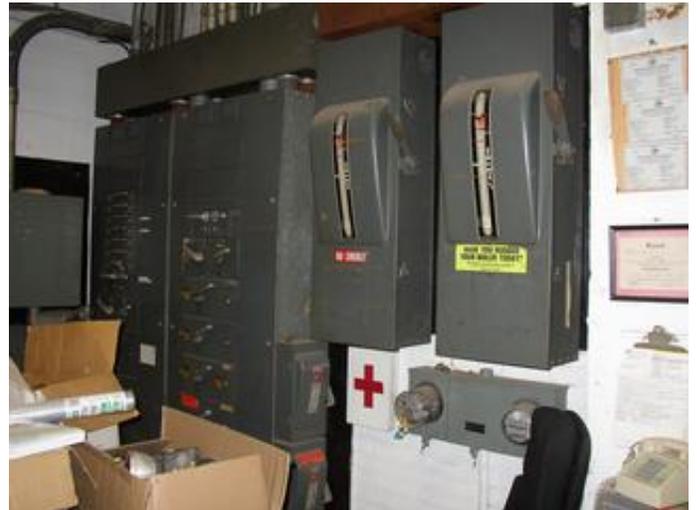
D. Electrical Systems

Description: The electrical service is located in the basement of the 1932 addition, and it consists of two (2) 240-volt, 3 phase, 400 ampere main disconnect switches. The service equipment is located in a dedicated area of the boiler room, and the power company's transformers are in an adjacent locked vault. The electric service is in fair condition, but it is not of adequate capacity for new air conditioning loads. The electrical distribution system consists of circuit breaker panelboards located in corridors. There is a stage lighting control panel located at the right of the stage. This panel dates to the 1963 addition and should be replaced. The overall electrical system is in fair to poor condition and should be replaced.

Rating: 3 Needs Replacement

Recommendations: A new electrical service is required to provide additional capacity to power the proposed air conditioning. Panelboards should be replaced with new panelboards located in electrical closets. Additional branch circuits to instructional areas should be provided. The stage lighting control panel should be replaced.

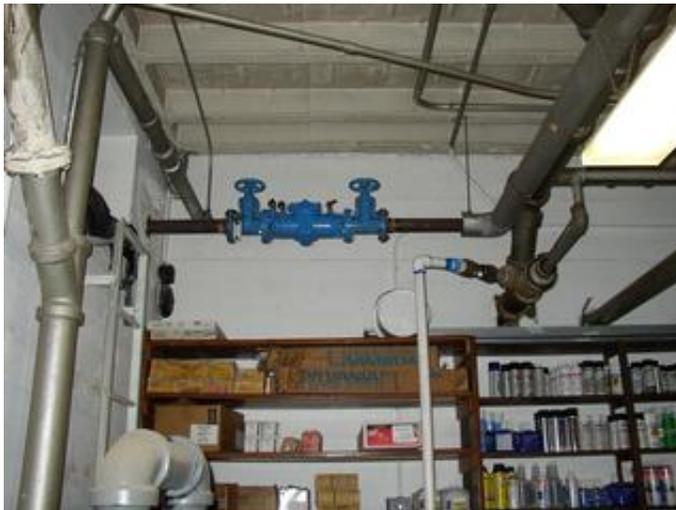
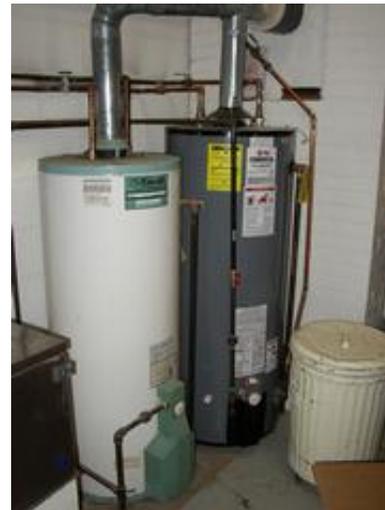
E. Plumbing and Fixtures

Description: The building water supply is from the local municipal water system. There is a backflow preventer at the water service entrance into the building. The water distribution piping throughout the building consists of both copper and galvanized piping. Water pressure is reportedly adequate. Domestic hot water for the toilet rooms and boys locker room in the south portion of the building is supplied from a gas-fired water heater located in the boiler room. This heater is in good condition. Another gas-fired water heater located between the second floor boys and girls toilets in the 1963 classroom addition provides hot water to the toilet rooms, art rooms, and science rooms. This heater is in good condition. Additionally, there are two (2) gas-fired water heaters located in a storeroom behind the kitchen serving the pot sink, dishwasher, etc. These heaters are in good condition. The sanitary system is predominantly cast iron pipe with no reported problems. There is a new duplex sewage ejector lift station in the basement that pumps only the basement floor drains into the overhead main sanitary system. The overall system is in fair condition. Water closets are a mix of floor-mounted and wall-hung types, with flush valves. Water closets in the 1963 classroom addition are wall-hung, A.D.A. compliant. Urinals are wall-hung, with a central flushing system.

Rating: 2 Needs Repair

Recommendations: Replace all galvanized domestic water piping with copper. Provide mixing valves on all domestic hot water systems. Replace all floor-mounted water closets, and other aging fixtures, as required.

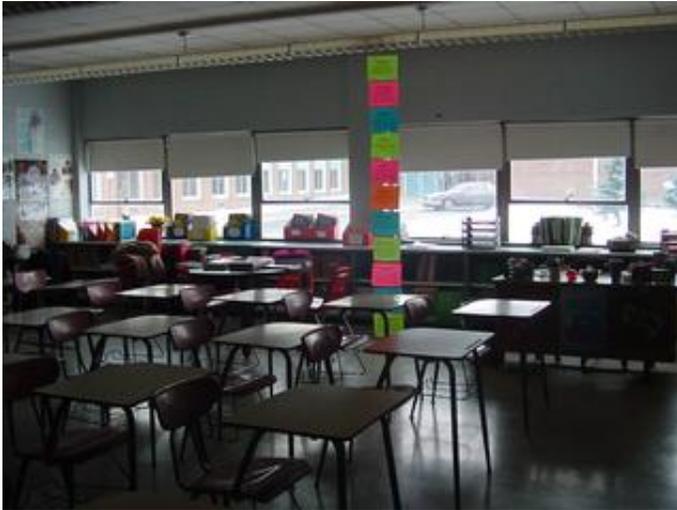
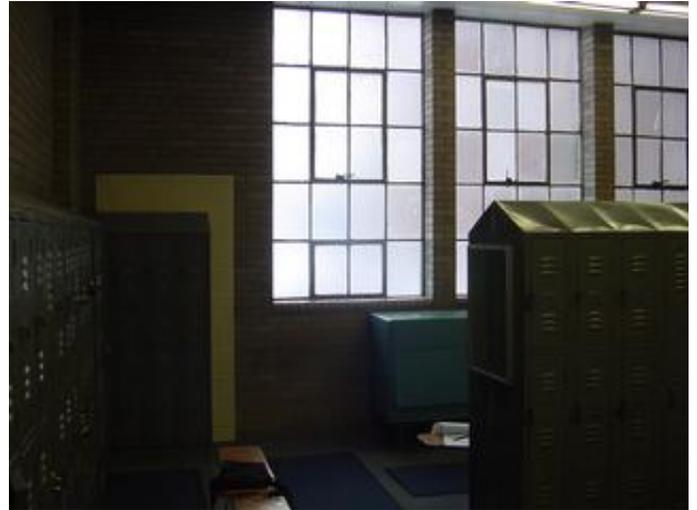
F. Windows

Description: The existing windows are single-glazed metal sash and are in poor condition. Many of the sash need to be re-glazed (putty). The windows in the 1923 and 1932 buildings appear to have been replaced at the time of the 1963 addition construction. The storefront systems for exterior doors (Section S) do not have insulated glass.

Recommendations: Replace all existing windows with thermally-broken units and insulating glass. Replace storefront systems for exterior doors.

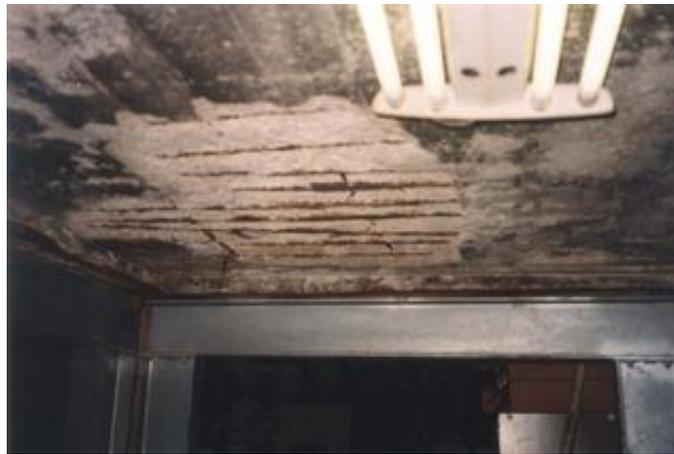
G. Structure: Foundation

Description: The entire building has load-bearing masonry walls. There is a concrete slab over the old coal bin that exhibits severe and extensive deterioration. The space below the slab should be abandoned and filled. It was reported that a termite infestation was discovered approximately fifteen years ago. The infestation was primarily in the sleepers and wood flooring over the ground level slabs on grade in the original building. Most of the wood was replaced with concrete slabs over the original slab on grade. The infestation has been abated.

Rating: 2 Needs Repair

Recommendations: Abandon the space under the deteriorated concrete slab and fill the space with concrete.

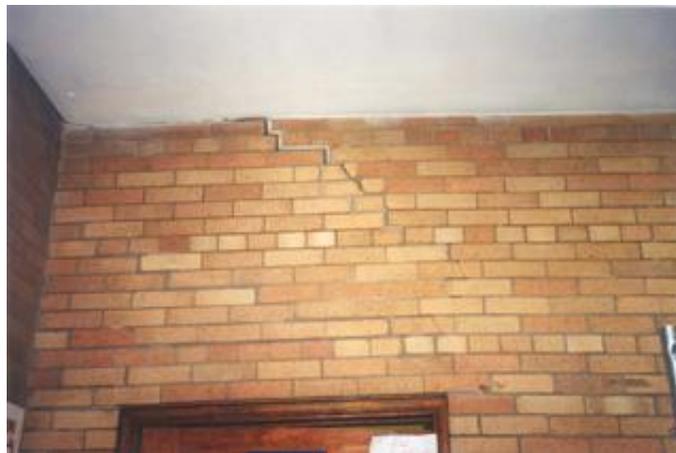
H. Structure: Walls and Chimneys

Description: The building has masonry walls, including both brick and concrete masonry units. There are many vertical control joints in the brick exterior walls where the sealant has failed. All brick control joints require new sealant. Approximately 300 lineal feet of joints is involved. There are corroded lintels over two window openings in the south wall of the 1932 addition. Approximately 30 lineal feet should be replaced. Some of the stone sill below the first story windows on the south side of the 1932 addition exhibits excessive movement. The sill should be removed and reset. There are no expansion joints in the older sections of the building.

Rating: 2 Needs Repair

Recommendations: Recaulk all exterior joints in brick walls. Replace corroded steel lintels; replace brick. Reset stone sill on south side.

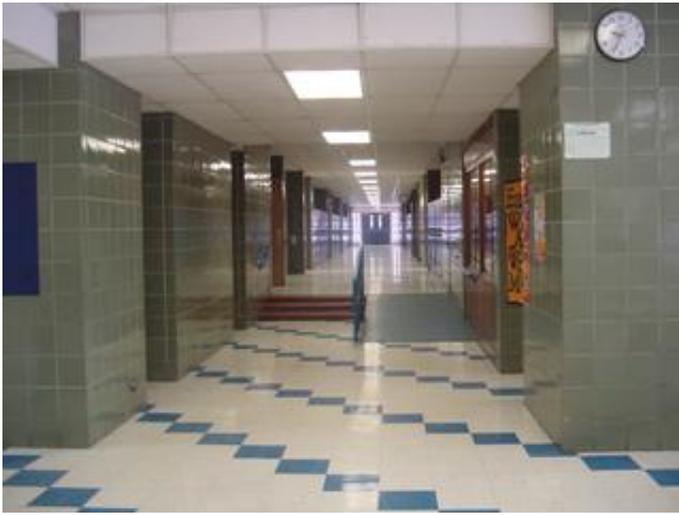
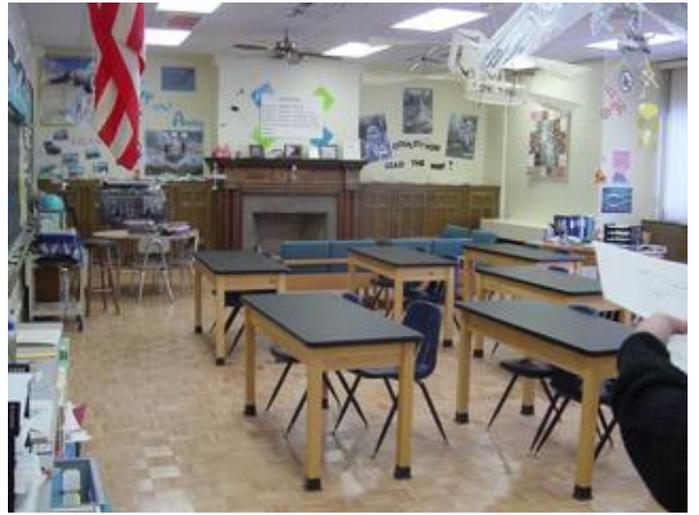
J. General Finishes

Description: Most walls are brick or painted concrete masonry units, and colors in some areas feel uncomfortable. Acoustic ceilings and fluorescent lighting have been recently upgraded in the 1923 and 1932 buildings. The acoustic ceilings and lighting in the 1963 building should be upgraded. Flooring consists of resilient (VCT), carpet, wood, quarry tile, and concrete. All are in fair condition. Tackboards and chalkboards all appear to be in good condition. Lockers are in fair condition, and unused lockers are secured with steel cable to prevent damage. Doors do not have accessible hardware, and they have non-safety glass. Toilet partitions are the original metal units and are in poor condition. One of the kitchen cooking appliances is not under the cooking hood.

Rating: 3 Needs Replacement

Recommendations: Repaint all concrete masonry and gypsum board walls. Replace all ceiling tiles and suspension systems throughout due to the installation of fire protection and ducted HVAC systems. The resilient flooring and carpeting should be replaced. Replace all toilet partitions and toilet accessories. See Section O (Handicapped Access) for door hardware replacement. Replace door glazing with safety or wire glass. (We estimate the cost per door for glazing replacement to be \$150.00.) Provide a new cooking hood for the oven.

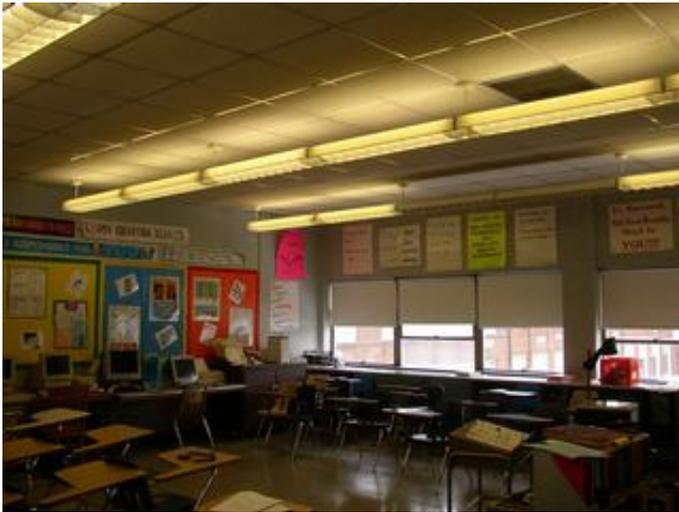
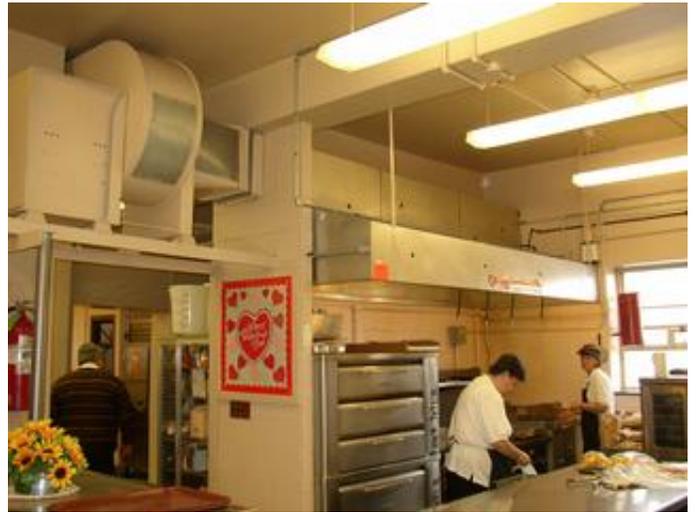
K. Interior Lighting

Rating: 3 Needs Replacement

Recommendations: Provide for the complete lighting replacement due to the installation of fire protection and ducted HVAC systems.

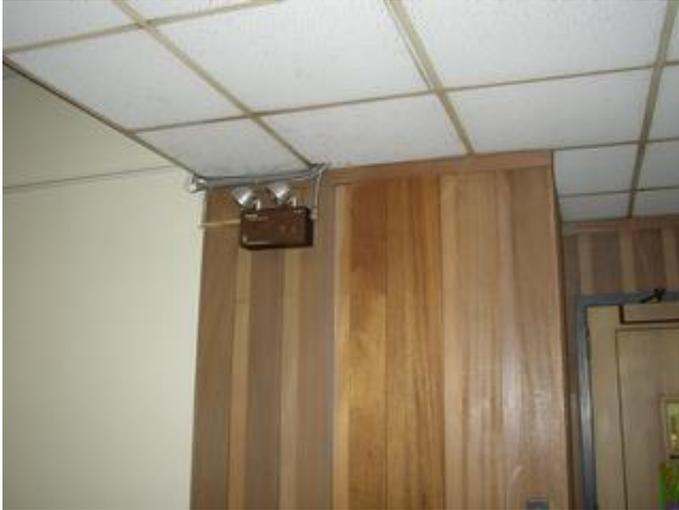
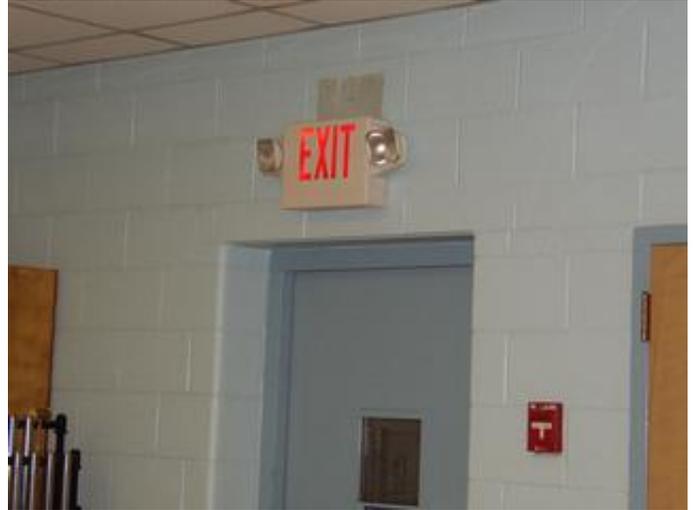
Description: The exit signs and the emergency/egress lighting utilize battery back-up fixtures. There has been an ongoing replacement program to change out aging emergency/egress fixtures with combination fixtures. The balance of the old fixtures must be replaced.

Rating: 3 Needs Replacement

Recommendations: Additional exit signs and emergency/egress lighting is needed to meet OSDM standards.

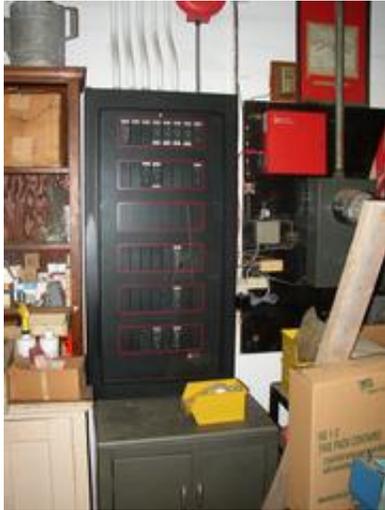
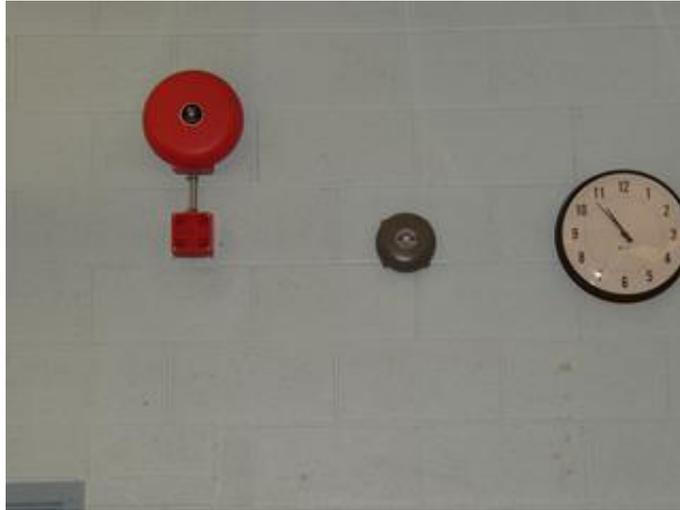
N. Fire Alarm

Description: The fire alarm system consists of a zoned fire alarm control panel (FACP) located in the boiler room. There are manual fire alarm pull stations, some ceiling-mounted smoke detectors, and audible wall-mounted alarm horns. The system does not meet A.D.A. or OSDM requirements. The FACP is in good condition and can likely be re-used. Various fire alarm devices are not adequate and should be replaced.

Rating: 3 Needs Replacement

Recommendations: Replace all fire alarm devices with A.D.A. compliant devices, including horn/strobes in the corridors, in the instructional areas, and in the toilet rooms.

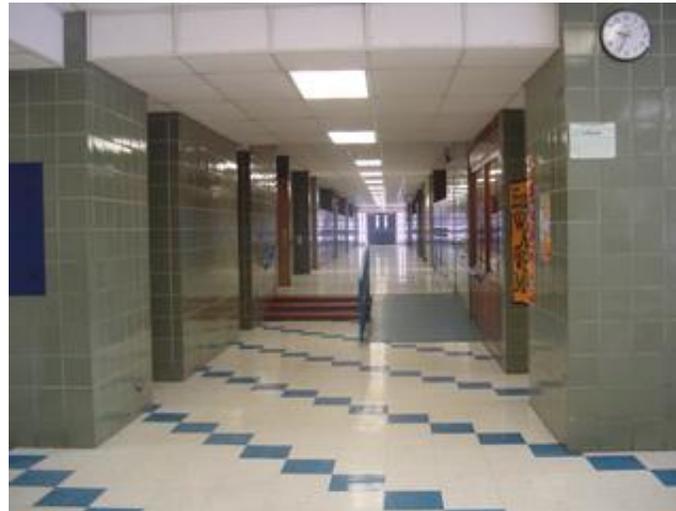
O. Handicapped Access

Rating: 3 Needs Replacement

Recommendations: Replace door hardware for A.D.A. compliance. Provide accessibility signage throughout the building. Provide one elevator for access between first and second floors, and wheel chair lifts for access to the music area. Water cooler and toilet fixture replacement for A.D.A. compliance is included in Section E (Plumbing and Fixtures). Provide accessible staff toilet facilities.

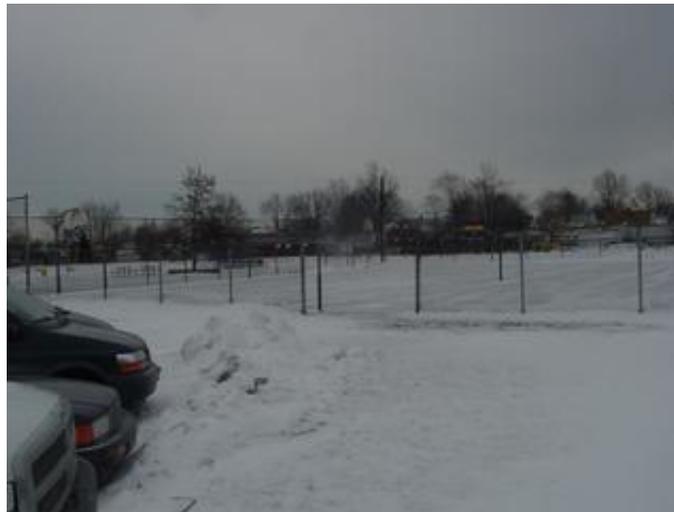
P. Site Condition

Description: The main site access is from Lincoln Road on the west side of the site. This area includes a drop-off circular drive, bus parking, and visitor parking. (Visitor parking is shared with the City Library.) The asphalt pavement is in fair condition with numerous cracks. The staff access and the parking and delivery areas are from Euclid Avenue on the north side of the site. This asphalt paving is also in fair condition. There are sufficient parking spaces for staff and visitors. The sidewalk system is adequate and in good condition.

Rating: 2 Needs Repair

Recommendations: Repair cracks in the asphalt drives and the parking areas. Provide new asphalt overlay in these areas.

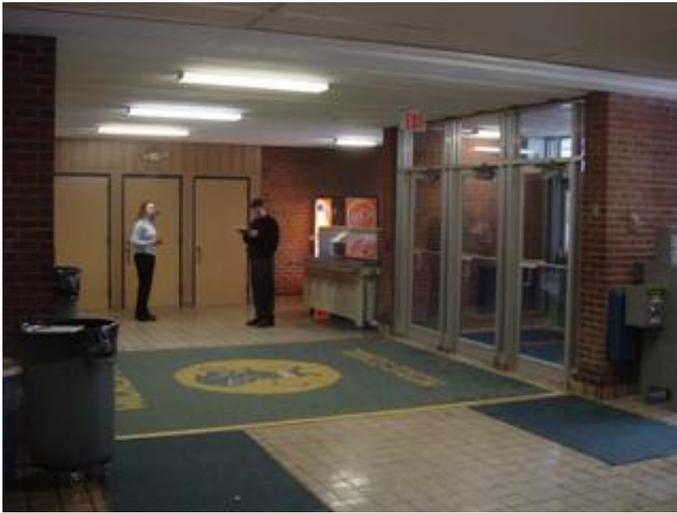
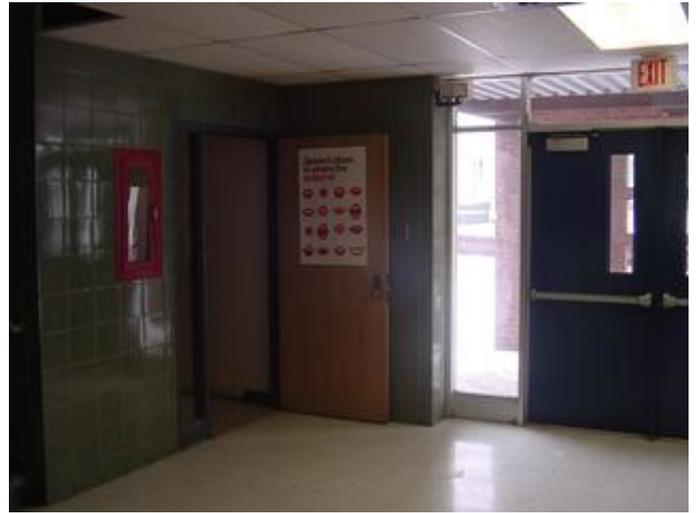
Description: The main entrance doors consist of a glass/aluminum storefront system in fair condition. Other entries consist of newer FRP doors in glass/aluminum storefront systems in fair condition. All exit doors have panic hardware.

Recommendations: Replace the storefront system including doors and hardware at the main entrance (1963 Gymnasium Addition).

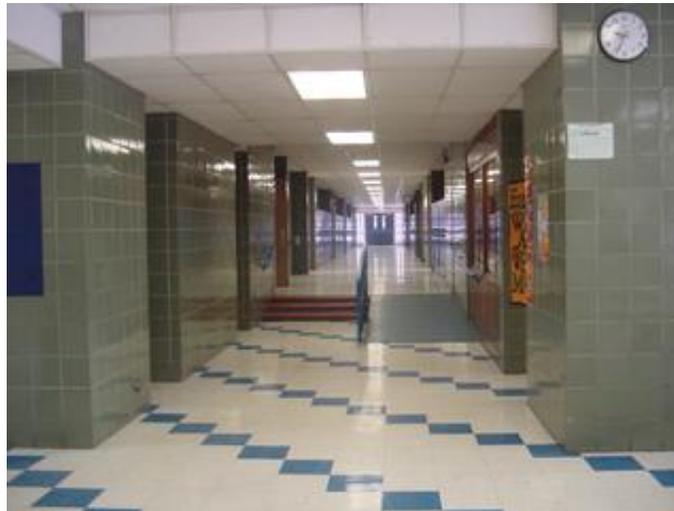
Rating: 3 Needs Replacement

Recommendations: Install a sprinkler system throughout per OSDM requirements. Replace all non-compliant handrails.

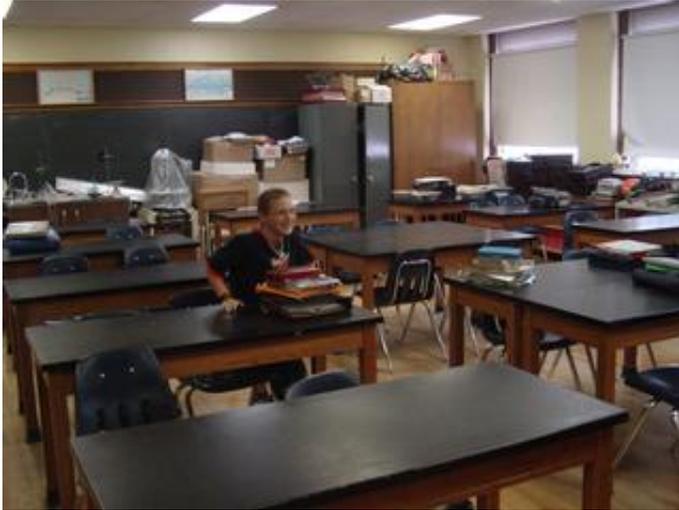
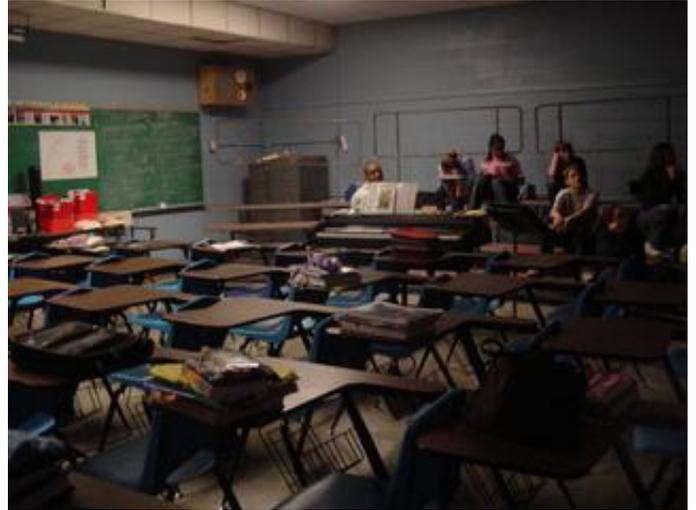
V. Loose Furnishings

Rating: 3 Needs Replacement

Recommendations: Replace older furnishings in the original 1923 building and the 1932 addition.

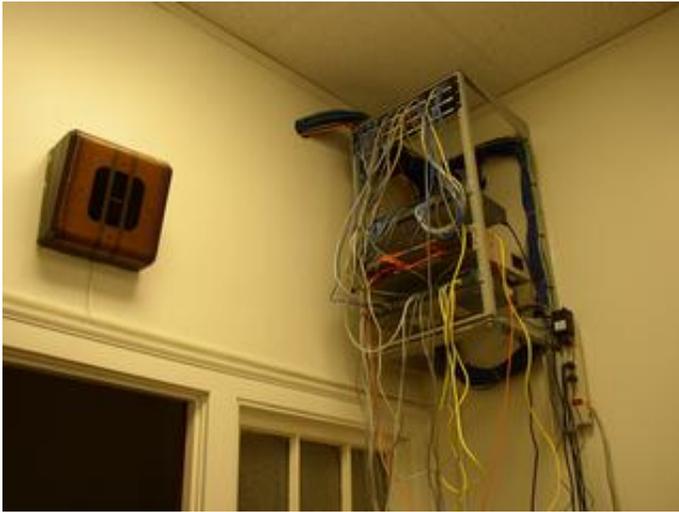
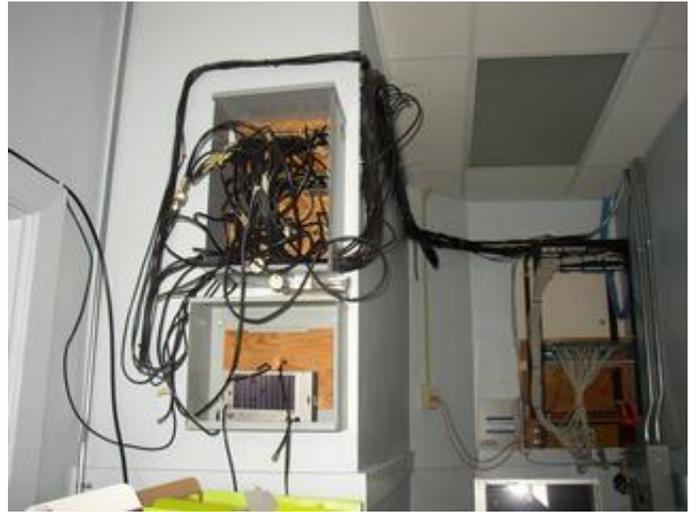
W. Technology

Rating: 3 Needs Replacement

Recommendations: Classroom telephones are needed. An Informational Delivery System (IDS) is needed. Additional fiber optics, data cabling and outlets are needed to comply with OSDM for a fully operational data system.
