**Building Information - Wickliffe City (45088) - Wickliffe High School**

Program Type	Expedited Local Partnership Program (ELPP)
Setting	Small City
Assessment Name	Wickliffe_High_School_2003_Assessment_10_05_18_Desktop_Update
Assessment Date (on-site; non-EEA)	2003-01-15
Kitchen Type	Full Kitchen
Cost Set:	2018
Building Name	Wickliffe High School
Building IRN	41202
Building Address	2255 Rockefeller Rd
Building City	Wickliffe
Building Zipcode	44092
Building Phone	440-944-0800
Acreage	66.00
Current Grades:	9-12
Teaching Stations	40
Number of Floors	2
Student Capacity	901
Current Enrollment	469
Enrollment Date	2002-05-22
Enrollment Date is the date in which the current enrollment was taken.	
Number of Classrooms	27
Historical Register	<b>YES</b>
Building's Principal	Brad Leyrer
Building Type	High

**Building Construction Information - Wickliffe City (45088) - Wickliffe High School (41202)**

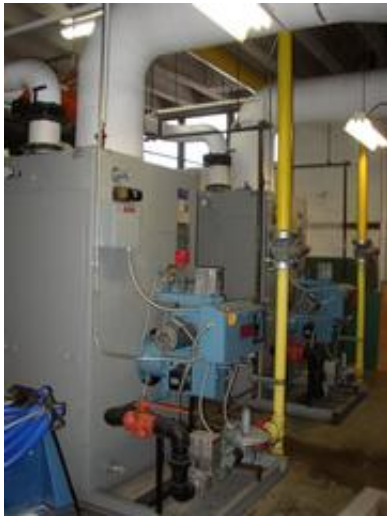
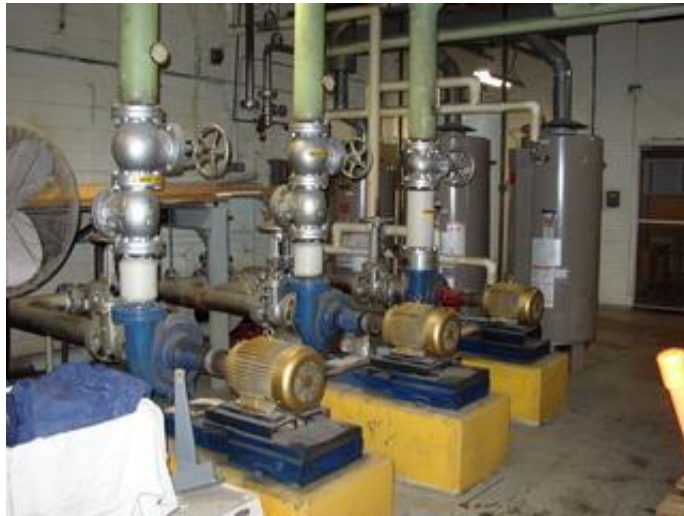
**Description:** There is a central heating water boiler plant located at the north end of the second floor in the original 1958 building. This central plant consists of two (2) gas-fired boilers that were replaced in 1997, with provisions for a future third boiler. It serves the entire high school facility. Heating water is distributed by three (3) heating water circulating pumps (two operating and one standby) through piping to unit ventilators, spiral tube radiators, unit heaters, cabinet unit heaters, and several heating and ventilating air handling units located throughout the building. A Landis & Staefa System 600 direct digital control (DDC) system was installed in 1997 to control boilers, pumps, unit ventilators, and heating and ventilating units. Air conditioning is limited to the 1999 science wing, some offices, the new performing arts center, and the cafeteria. Ventilation air is supplied by two (2) penthouse air handling units and through unit ventilators. Proper quantities of outside air cannot be determined without an air flow measurement. The kitchen hoods do not have a source of make-up air, and are forty-five (45) years old. These should be replaced. The dishwasher hood is in good condition and may be re-used.

**Rating:** 3 Needs Replacement

**Recommendations:** Except for in the new science wing, provide a complete replacement of the unit ventilator system with a fully ducted air conditioning system in the instructional areas. The new system will supply conditioned air, and provide the proper OMC outside air quantities to each space. Refurbish or replace the two (2) penthouse air handling units, and provide a ducted return air system that doesn't utilize the corridors as return air plenums. Retain the existing boiler plant and pipe distribution systems. Modify as needed for new heating water coils and other devices. Air conditioning shall be added by the installation of a chiller, chilled water piping, pumps, and cooling coils. The new chiller should work in conjunction with the existing air-cooled chiller installed for the science wing. The DDC system should be expanded to control all new HVAC systems.

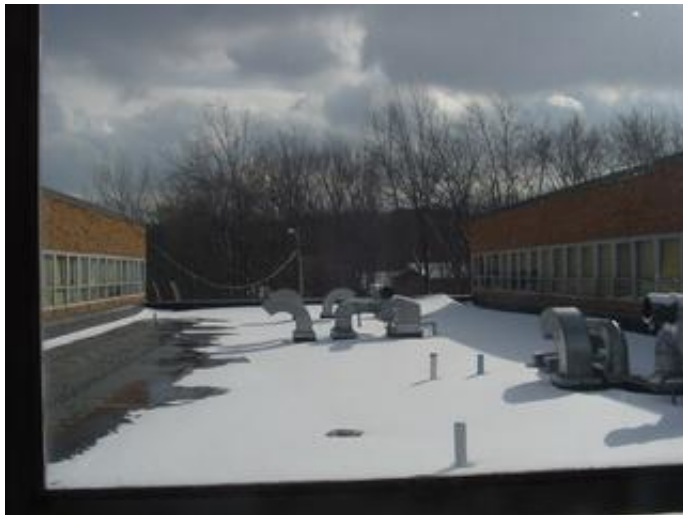
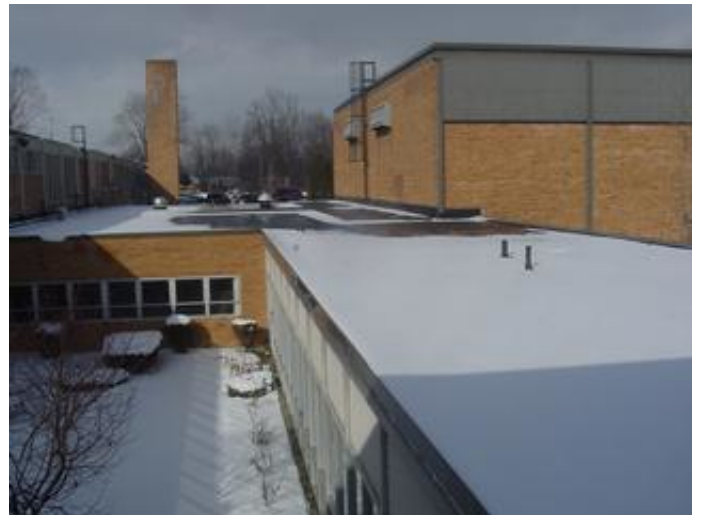
B. Roofing

**Description:** Approximately 55 percent of the roof areas are modified bitumen roofing with minimal slope and some ponding. These roofs were installed in 1991 and are no longer under warranty. There are two known leaks and numerous blisters/ridges in the membrane. The balance of the roof areas are 0.060 EPDM with minimal slope and some ponding. These roof areas were installed in 1990 and are no longer under warranty. These roofing areas are generally in good condition, but some soft/wet areas were found.

**Rating:** 3 Needs Replacement

**Recommendations:** Replace all roofing, edge metal, and flashings. Include tapered insulation to provide positive drainage. Allow for 10 percent of roof areas for deck replacement. Note: the roofing replacement does not include for the 1999 addition.

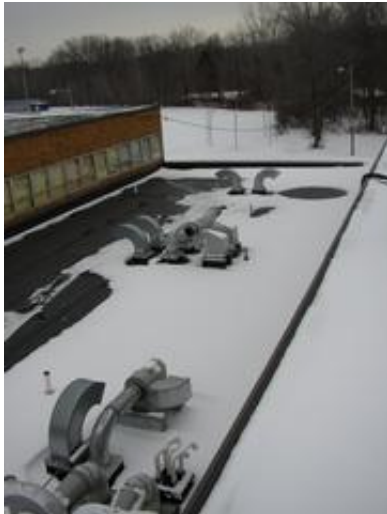
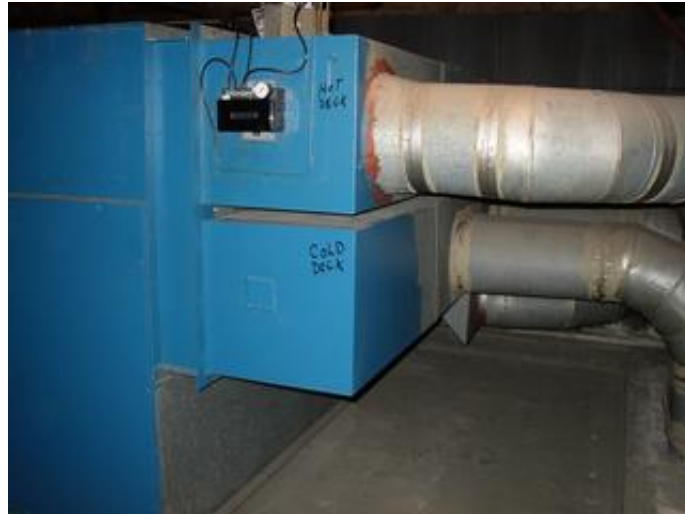
### C. Ventilation / Air Conditioning

**Description:** Ventilation air is supplied through the two (2) penthouse heating and ventilating units and through unit ventilators to the instructional spaces. Individual heating and ventilating units located in the instrument storage room serve the vocal room, the band room, and the instrument storage room. There are two (2) heating and ventilating units hanging in the gymnasium, along with two (2) roof-mounted exhaust fans. The boys and girls locker rooms, located below the gym, each have a make-up air and exhaust system. The new science wing is air conditioned through four-pipe fan-coil units and a chiller. The science wing has several roof-mounted exhaust fans. Miscellaneous exhaust systems serve the metal shop, the wood shop, the machine shop, and the power mechanics shop. There is a dust collector outside of the wood shop. A major deficiency exists in the ventilation system from the two (2) penthouse units in that they utilize the corridors for return air flow in violation of current code.

**Recommendations:** Provide air conditioning in the original building and in the 1963 addition.

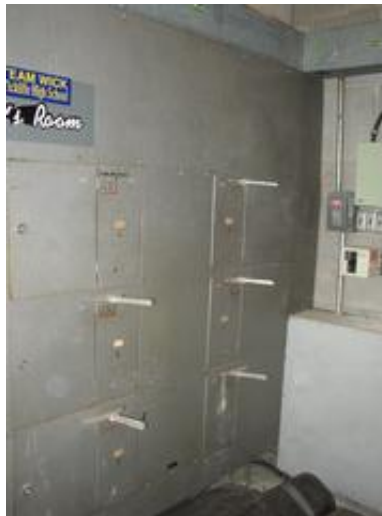
D. Electrical Systems

**Description:** The electrical service is located on the second floor of the original building, across from the boiler room. It is 120/208 volt, 3-phase, 1600 amperes. The service entrance is in a dedicated room, with the power company's transformer pad-mounted directly outside. The electric service is in good condition but is not of adequate capacity for new air conditioning loads. The electrical distribution system consists of circuit breaker panelboards distributed throughout the building. The overall electrical system is in good condition and should be retained and expanded as required.

**Rating:** 3 Needs Replacement

**Recommendations:** The existing electrical service should be expanded to provide additional capacity to power the proposed air conditioning. Additional panelboards and branch circuits should be provided to instructional areas as required.

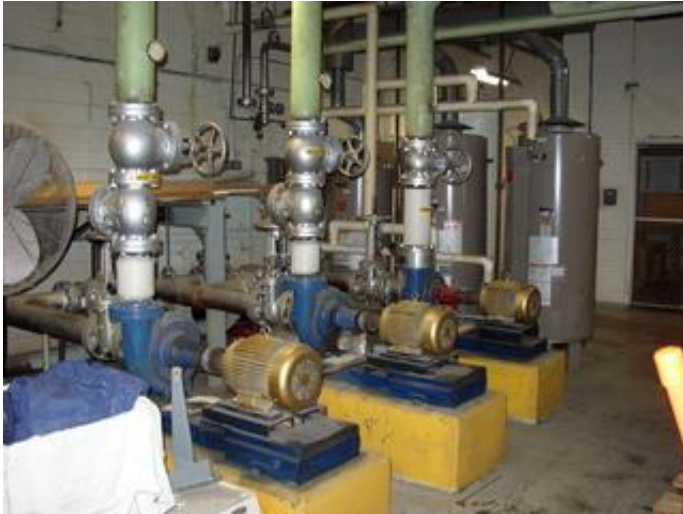
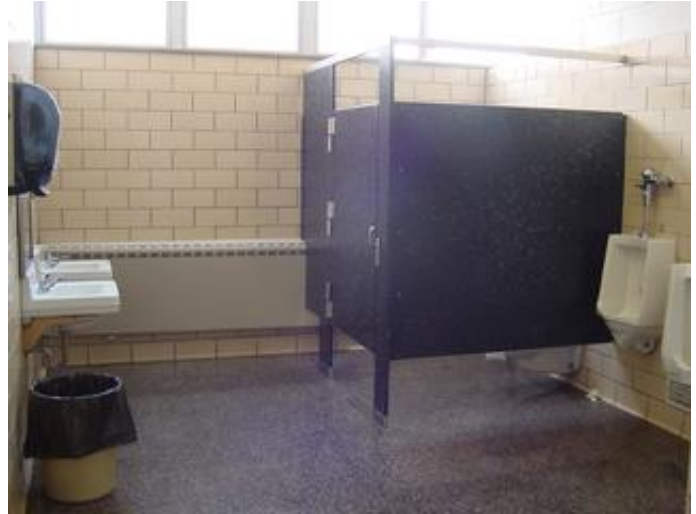
E. Plumbing and Fixtures

**Description:** The building water supply is from the local municipal water system. There are backflow preventers at the water service entrance and on the connection of the HVAC make-up water to the potable domestic water. The water service piping is cement-lined cast iron, and the distribution piping throughout the building is copper. Water pressure is reportedly adequate. Domestic hot water is supplied from three (3) gas-fired water heaters that are manifolded together and are located in the boiler room. These heaters are in good condition and can be re-used. There are "master" shower controls with individual mixing valves for the boys and girls locker room showers. The sanitary system is predominantly cast iron pipe with no reported problems. Individual sinks in the new science wing have polypropylene acid waste piping into neutralizing strips located at each sink. The overall sanitary system is in good condition. Water closets and urinals are all wall-hung with flush valves. Lavatories are wall-hung.

**Rating:** 2 Needs Repair

**Recommendations:** Replace all aging fixtures as required. Provide individual hot and cold, single lever pressure balancing valves and vandal-resistant shower heads for each locker room shower per OSDM requirements.

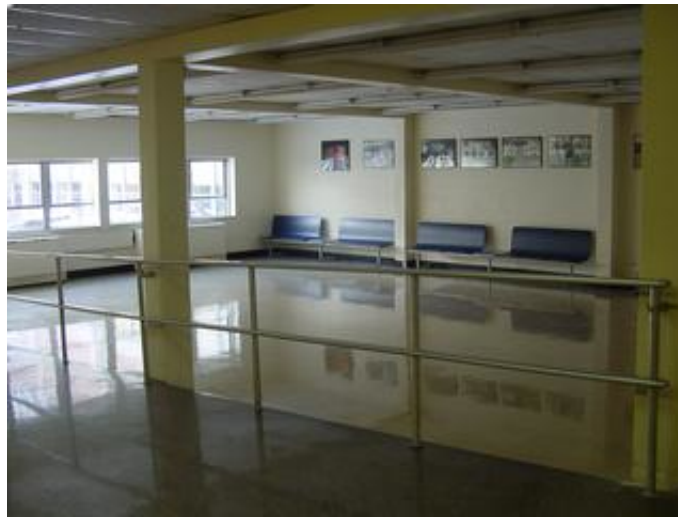
F. Windows

Description: The existing storefront systems and window units are not thermally broken, and they have single-pane glazing. Most of the window units need extensive re-puttying.

Rating: 2 Needs Repair

Recommendations: Replace all existing storefront glazing systems and window units with thermally broken units and insulating glass.

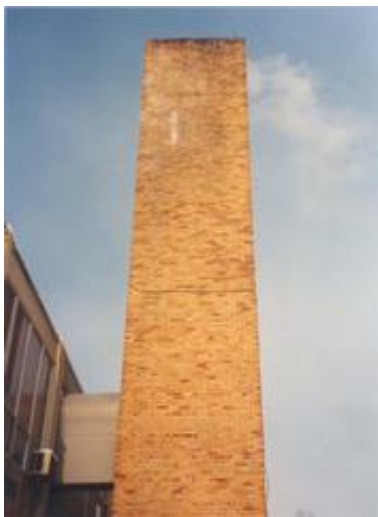
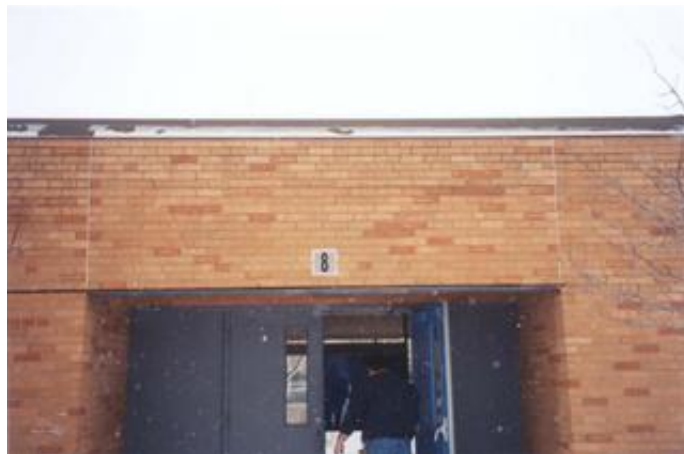
**Description:** The original building, with the exception of the gymnasium, has a cast-in-place concrete frame. There were two additions in 1963. One addition, the south classroom wing, has a cast-in-place concrete frame. The other addition, the north shops, is one story with a precast concrete roof. The gymnasium and the 1999 addition have steel frames. The building has four expansion joints. The vertical portions on the joints through the exterior walls require new seals. There are many vertical control joints in the brick exterior walls where the sealant has failed. All brick control joints require new sealant. Approximately 200 S.F. of brick on the east wall of the building exhibits cracking and out-of-plane displacement and needs to be removed and replaced. This displacement is caused by a steel lintel that is corroding and needs to be replaced. There is a corroded lintel over an opening in the east wall at the north end of the building that needs to be replaced. Approximately 100 S.F. of repointing is required for the brick walls at the south end of the building. Approximately 700 S.F. of brick on the surface of the chimney needs to be repointed. Some of the masonry on the interior surface of the west wall of the gymnasium exhibits cracking and slight out-of-plane displacement. The brick on the exterior surface of the wall exhibits no defects. The interior wall will need to be repaired by relaying and repointing. Approximately 200 S.F. of replacement and approximately 200 S.F. of repointing is involved.

**Rating:** 2 Needs Repair

**Recommendations:** Replace expansion joint seals. Replace control joint sealant. Replace brick on east side. Replace steel lintels. Repoint brick on the east wall. Repoint masonry at the chimney. Replace/repoint masonry at gym.

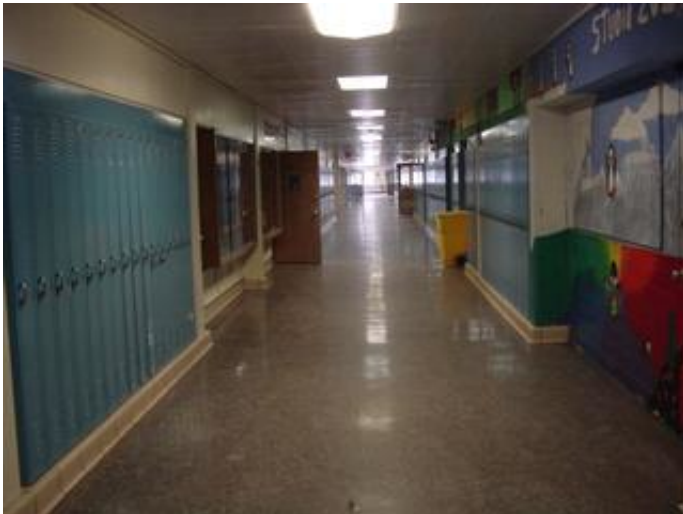
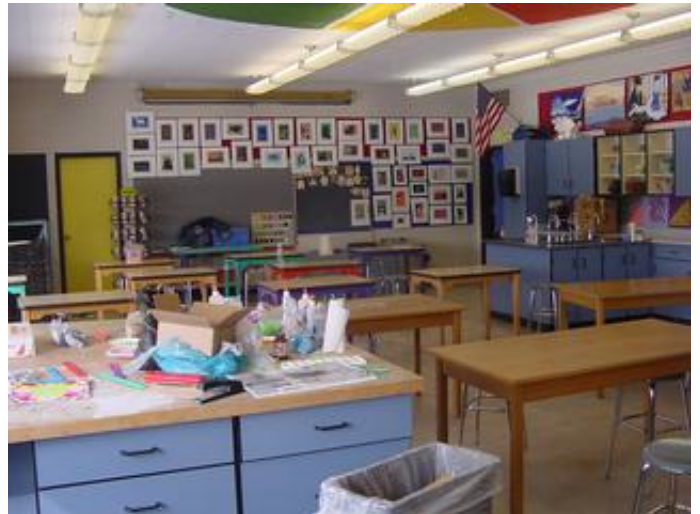
J. General Finishes

**Description:** Interior walls consist of painted concrete masonry units or structural glazed facing tile. The paint colors used are compatible with the tile. Most ceilings throughout the building are 2x4 acoustic panels in fair condition. The floors and walls generally have no acoustic treatment. Tackboards and chalkboards all appear to be in good condition. Lockers appear adequately sized, and they generally function well. Doors do not have accessible hardware, and many have non-safety glass. Toilet partitions are the original metal units and are in fair condition. The cafeteria and kitchen have sufficient space and are nicely arranged.

**Rating:** 3 Needs Replacement

**Recommendations:** Repaint all concrete masonry and gypsum board walls. Replace all ceiling tiles and suspension systems throughout due to the installation of fire protection and ducted HVAC systems. The resilient flooring should be replaced. See Section O (Handicapped Access) for door hardware replacement. Replace door glazing with safety or wire glass. (We estimate the cost per door for glazing replacement to be \$150.00.) Replace all toilet partitions and toilet accessories.

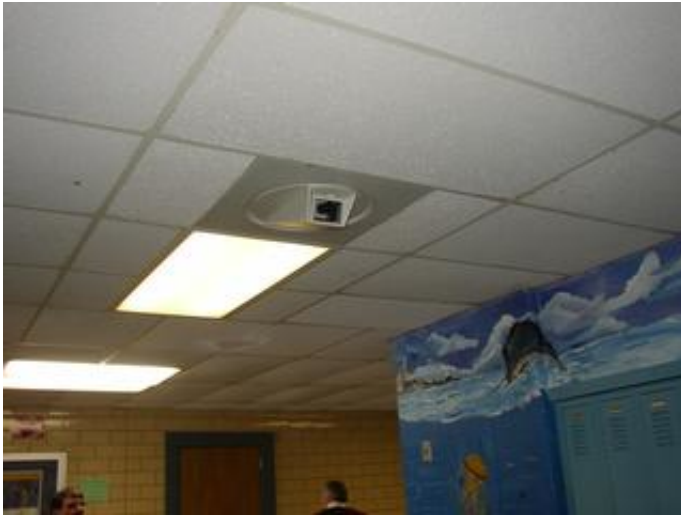
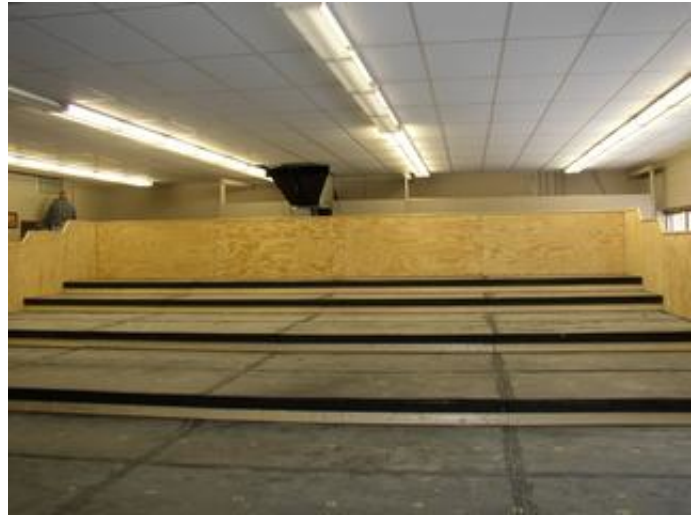
## K. Interior Lighting

**Rating:** 3 Needs Replacement

**Recommendations:** Provide for the complete lighting system replacement in areas where new fire protection and ducted HVAC systems will be installed.

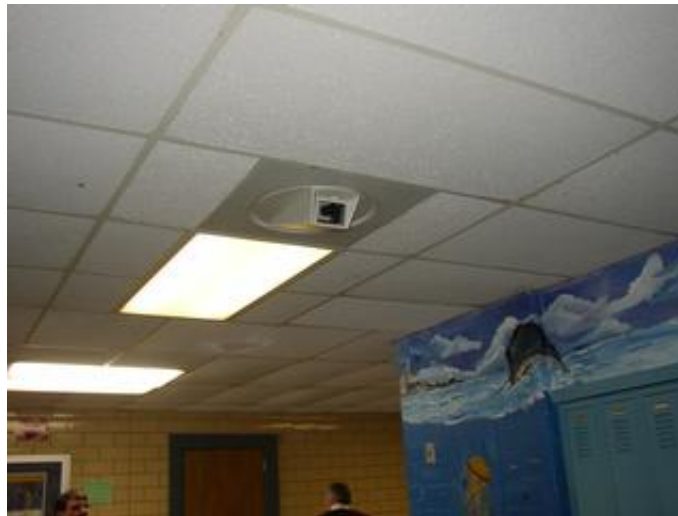
L. Security Systems

Description: The security system consists of four (4) cameras monitoring exterior doors and motion detectors in the corridors. Additionally, there are motion detectors in the computer lab and in the greenhouse. Although not observed, exterior lighting reportedly is adequate for building security.

Rating: 3 Needs Replacement

Recommendations: A new OSDM compliant security system needs to be installed.

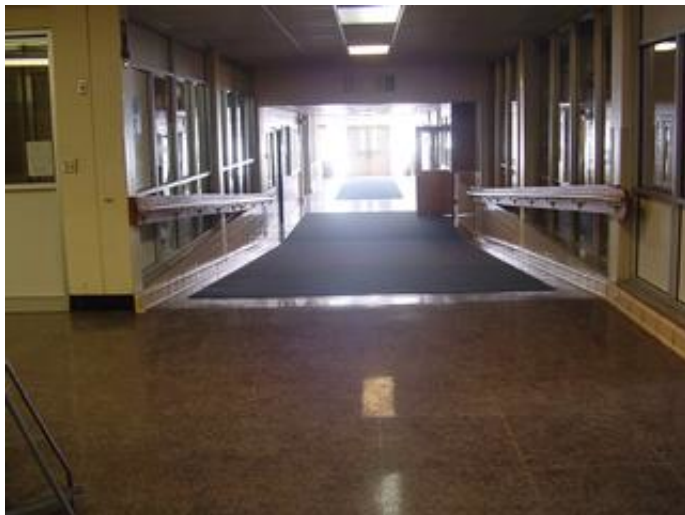
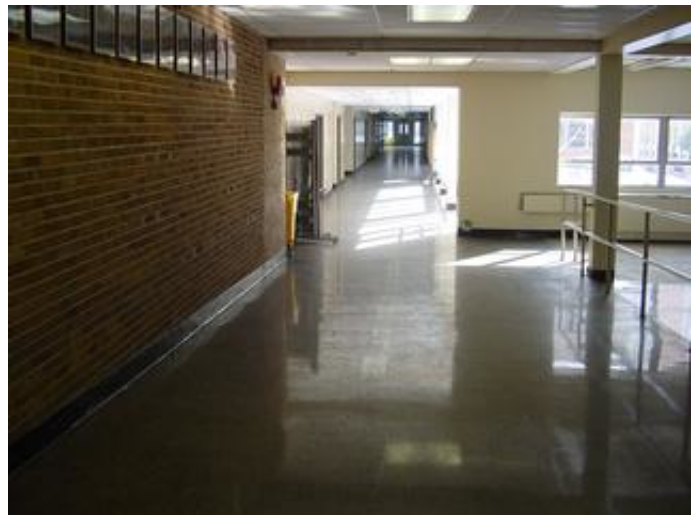
**Rating:** 3 Needs Replacement

**Recommendations:** Replace door hardware for A.D.A. compliance. Provide accessibility signage throughout the building. Provide one elevator for access between the first and second floors. Water cooler and toilet fixture replacement for A.D.A. compliance is included in Section E (Plumbing and Fixtures). Provide accessible toilet facilities for staff and students. Provide one power-assist door at the main entrance.

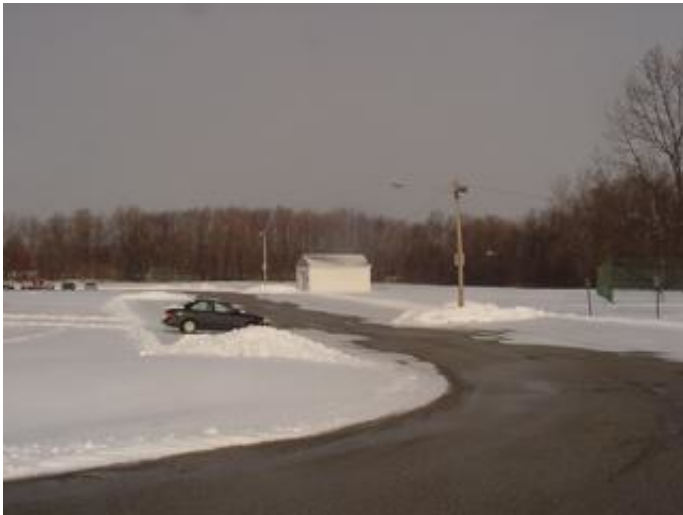
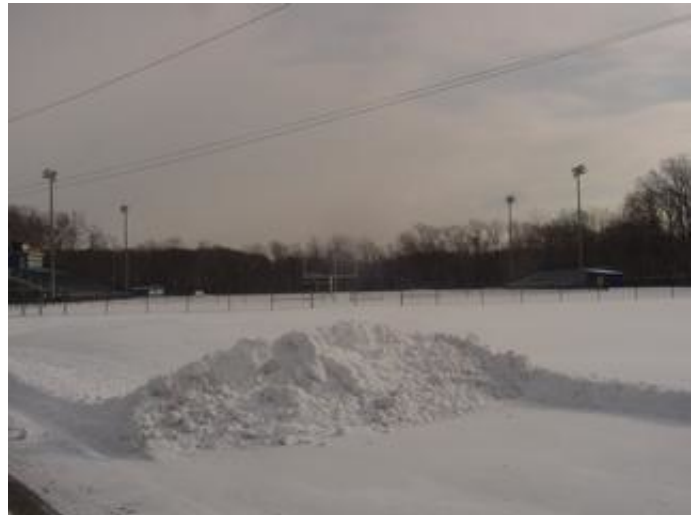
P. Site Condition

**Description:** The site is located in a quiet residential neighborhood and is a short distance from Euclid Avenue. The site is adequately landscaped and shows no signs of erosion. Well equipped athletic facilities for baseball, football, tennis, and track are located on-site. Retaining walls in two locations lack handrails for safety. There is sufficient asphalt-paved parking in fair condition. The concrete sidewalks are in fair condition and connect all building exits and site features. Curb cuts are provided where needed. The bus drop-off area is combined with the visitor parking area. Other pedestrian and vehicular access to and through the site are fairly well laid out.

**Rating:** 2 Needs Repair

**Recommendations:** Provide minor crack repair and a new wearing course on all asphalt pavement. Provide hand/guard rails on top of retaining wall for safety.

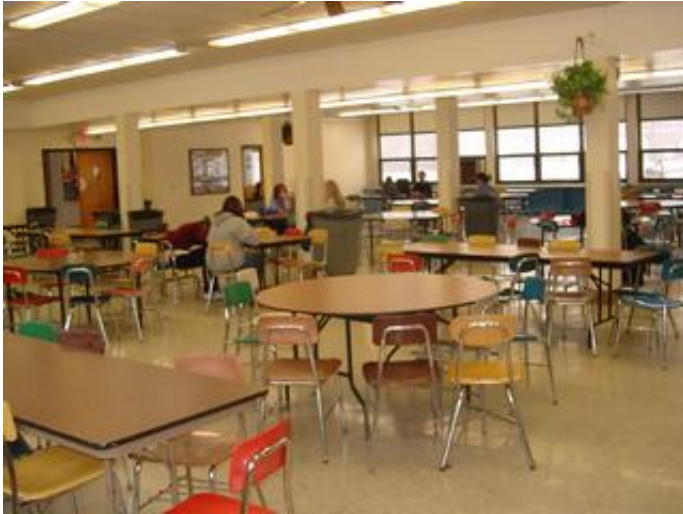
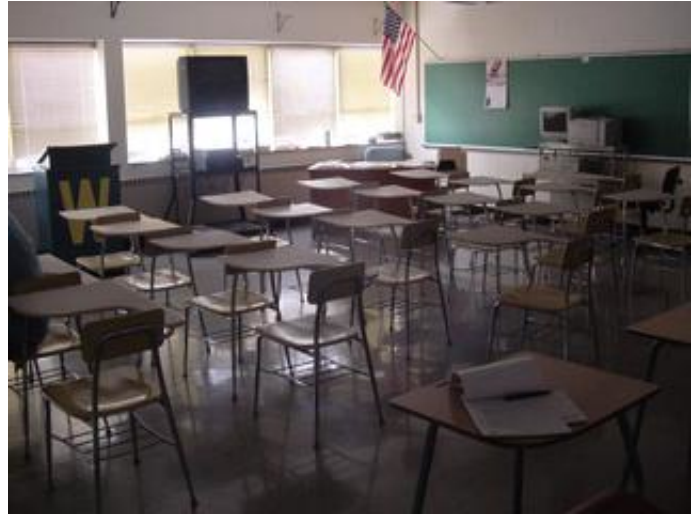
V. Loose Furnishings

Rating: 3 Needs Replacement

Recommendations: Replace older furnishings in the original 1958 building and the 1963 additions.

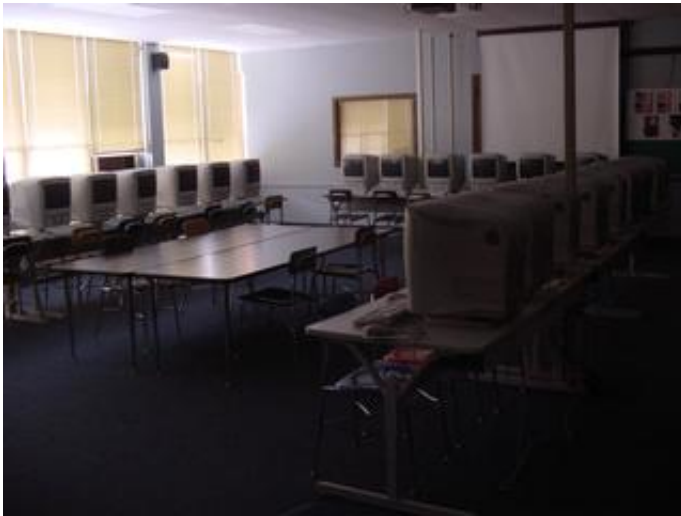
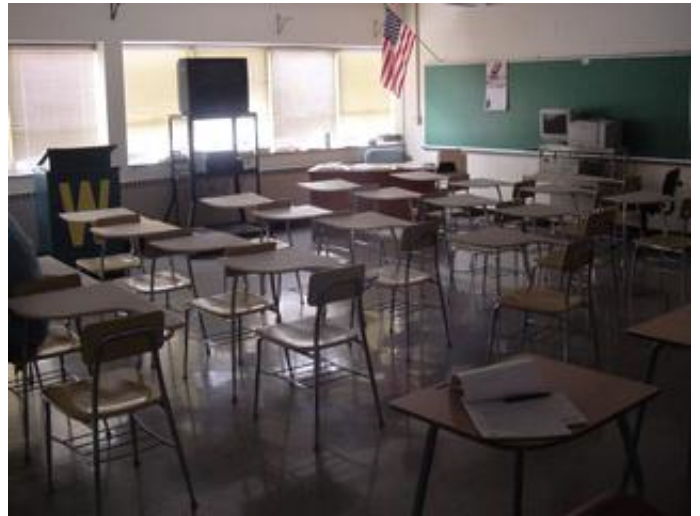
W. Technology

**Rating:** 3 Needs Replacement

**Recommendations:** Classroom telephones are needed. An Informational Delivery System (IDS) is needed. Additional fiber optics, data cabling and outlets are needed to comply with OSDM for a fully operational data system. The 1999 addition does comply.
