Building Information - Wickliffe City (45088) - Wickliffe Elementary School

Program Type	Expedited Local Partnership Program (ELPP)
Setting	Small City
Assessment Name	Wickliffe_Elementary_2003_Assessment_With_2018_Cost_Set_Revised_11_02_18
Assessment Date (on-site; non-EEA)	2003-01-14
Kitchen Type	Full Kitchen
Cost Set:	2018
Building Name	Wickliffe Elementary School
Building IRN	20776
Building Address	1821 Lincoln Rd
Building City	Wickliffe
Building Zipcode	44092
Building Phone	440-943-0320
Acreage	2.29
Current Grades:	PK-4
Teaching Stations	38
Number of Floors	2
Student Capacity	422
Current Enrollment	558
Enrollment Date	2002-05-22
Enrollment Date is the date in which the current enrollment was taken.	
Number of Classrooms	32
Historical Register	NO
Building's Principal	Kelly Bearer
Building Type	Elementary

This facility was originally constructed in 1923 as a two-story building on the same site as Wickliffe Middle School. A basement area providing access to mechanical and crawl spaces is entered from the 1949 addition. The structure of the original building consists of concrete slabs on steel framing for the floors, load-bearing masonry walls, and wood framing for the roof. Ther

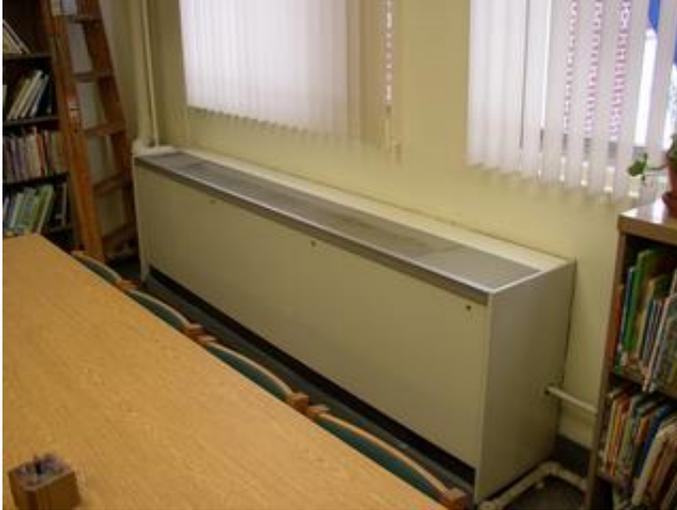
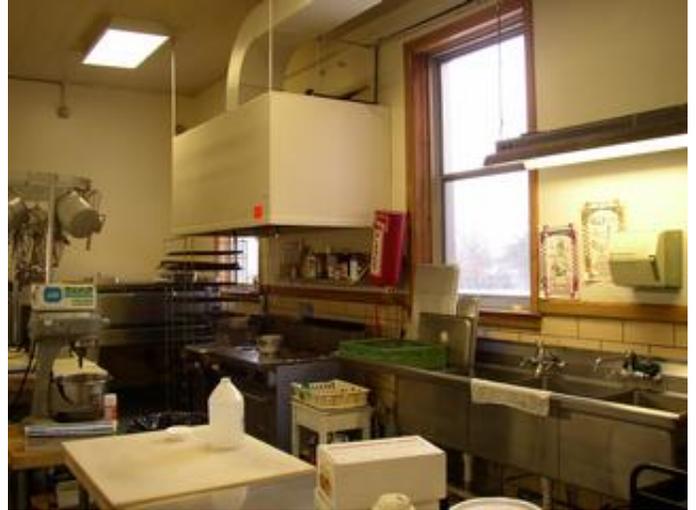
C. Ventilation / Air Conditioning

Description: The unit ventilators throughout the building provide some ventilation air. However, the outdoor air quantities are assumed to be insufficient to meet current OMC and OSFC requirements. The gymnasium heating and ventilating unit does provide fresh air to this space, but the equipment is very old and should be replaced. Air conditioning is limited to the school office and to the clinic. There is no source of make-up air for the range hood or dishwasher hood in the kitchen.

Recommendations: Provide air conditioning. These costs are included in the complete HVAC system replacement in Section A (Heating System).

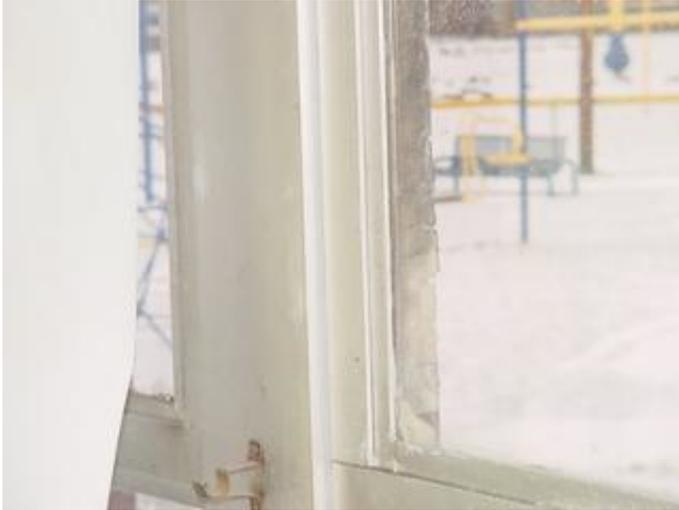
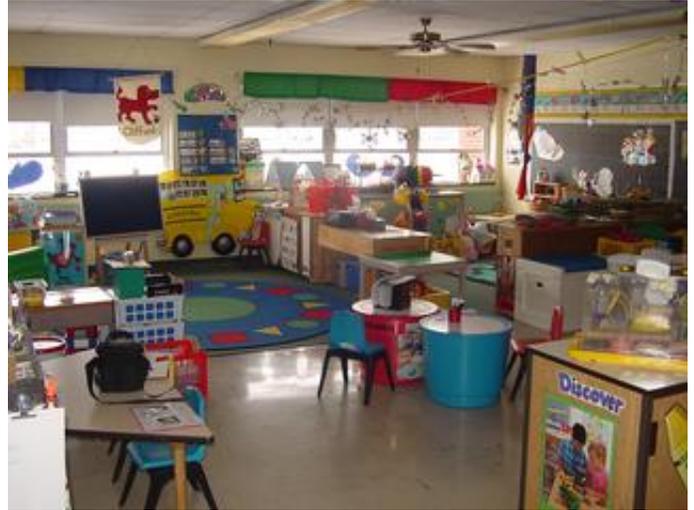
Rating: 3 Needs Replacement

Recommendations: Replace all existing windows with thermally-broken units and insulating glass.

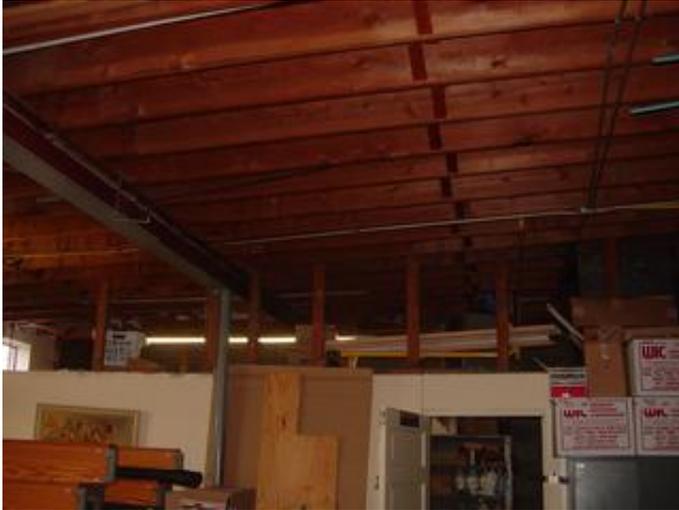
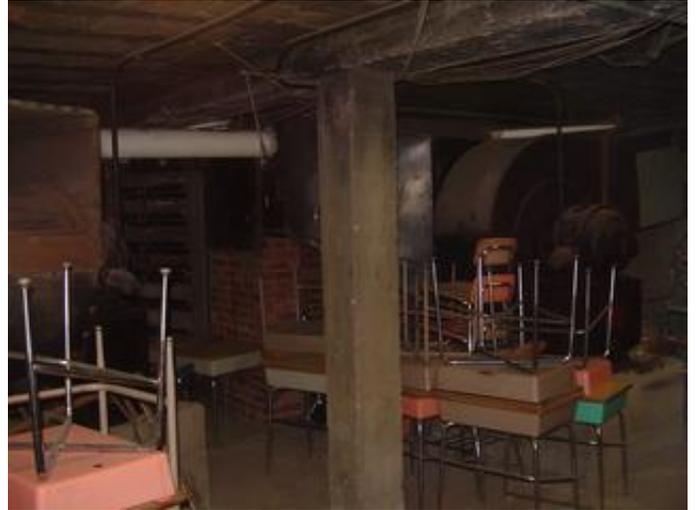
Rating: 2 Needs Repair

Recommendations: Add fire rated drywall over the existing wood ceiling joists in the original building.

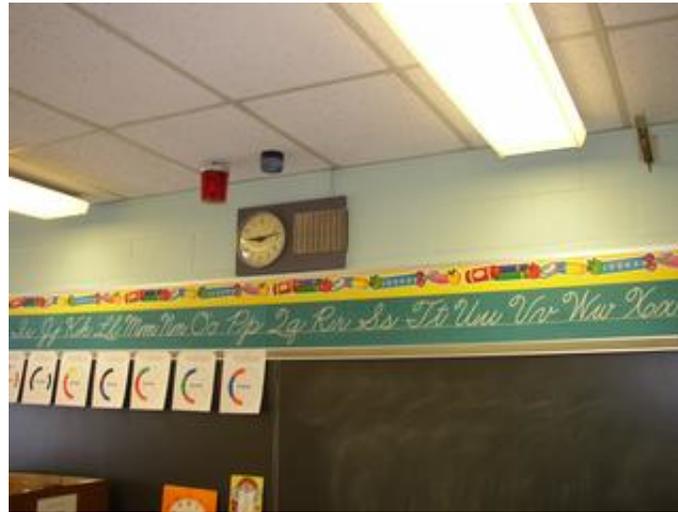
Rating: 3 Needs Replacement

Recommendations: Provide for the complete lighting system replacement due to the installation of fire protection and ducted HVAC systems.

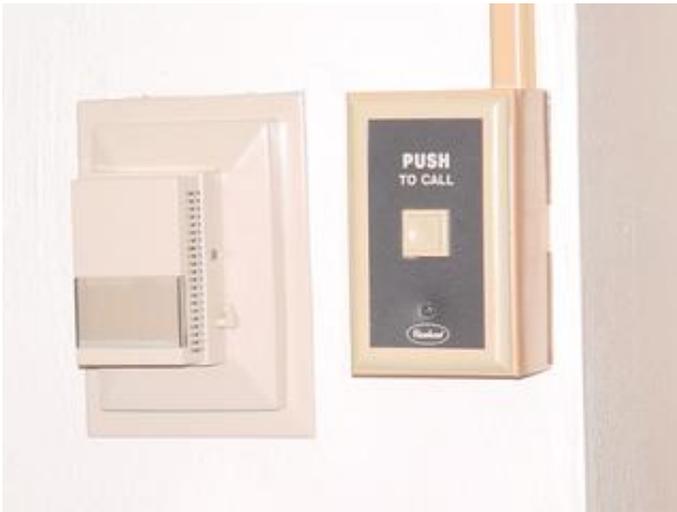
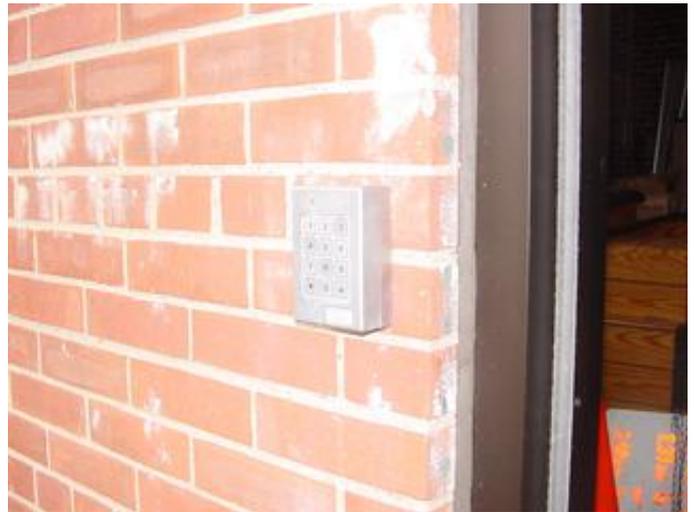
L. Security Systems

Rating: 3 Needs Replacement

Recommendations: A new OSDM compliant security system needs to be installed.

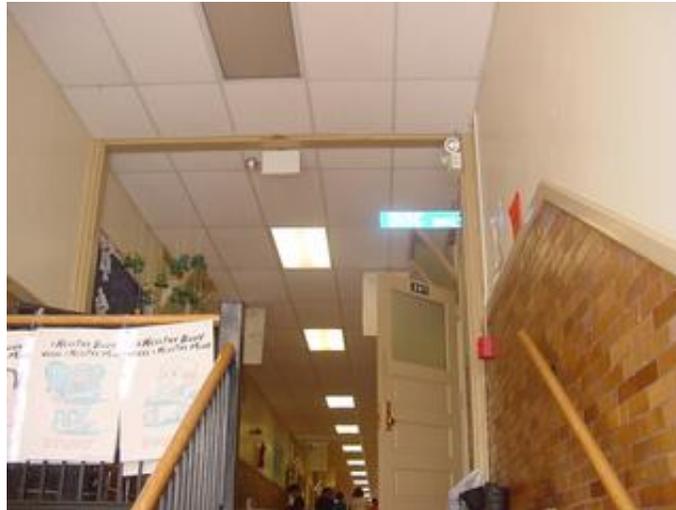
M. Emergency/Egress Lighting

Description: The exit signs and the emergency/egress lighting utilize battery back-up fixtures. The exit signs and the emergency/egress lighting fixtures are in average condition and are not adequate.

Rating: 3 Needs Replacement

Recommendations: Additional exit signs and emergency/egress lighting is needed to meet OSDM standards.

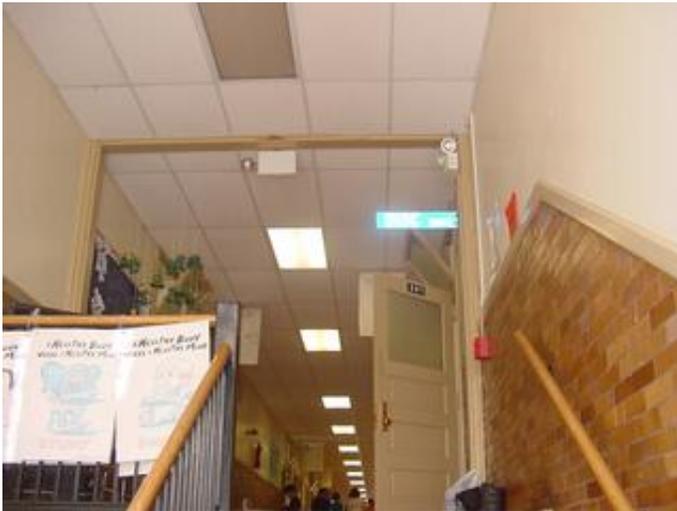
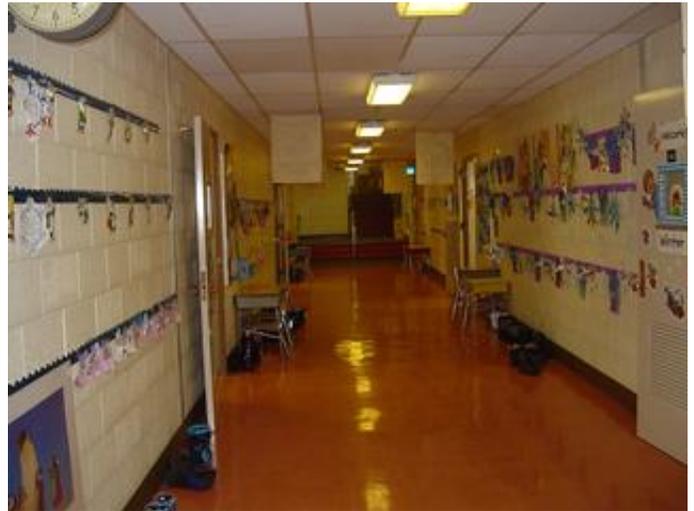
Rating: 3 Needs Replacement

Recommendations: Replace door hardware for A.D.A. compliance. Provide accessibility signage throughout the building. Provide one elevator for access between the first and second floors in the 1923 building, and provide wheel chair lifts at the level changes between the 1949 and 1963 additions. Water cooler and toilet fixture replacement for A.D.A. compliance is included in Section E (Plumbing and Fixtures). Provide accessible toilet facilities for staff and students. Provide one power-assist door at the main entrance.
